# Final Report

Replacing Engine #1 installed on the aircraft Boeing 737-800

Registered as UR-CLR

Aircraft Accident Investigation Central Directorate

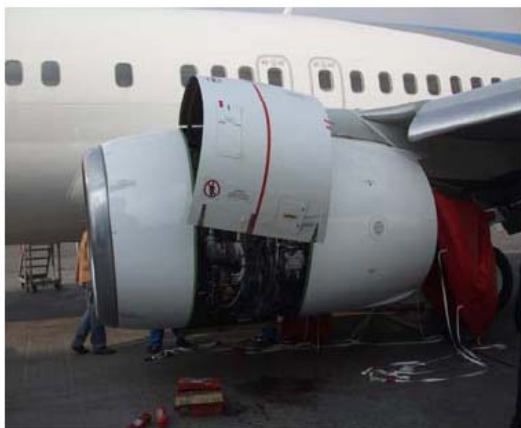
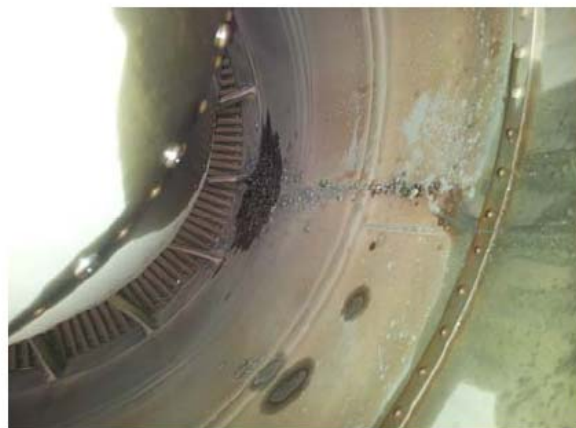
The aircraft experienced damage in #1 engine

- Engine #1 was replaced with new overhauled engine as per AMM, found ok.
- Engine #1 operational check was varied out as per AMM, found ok.

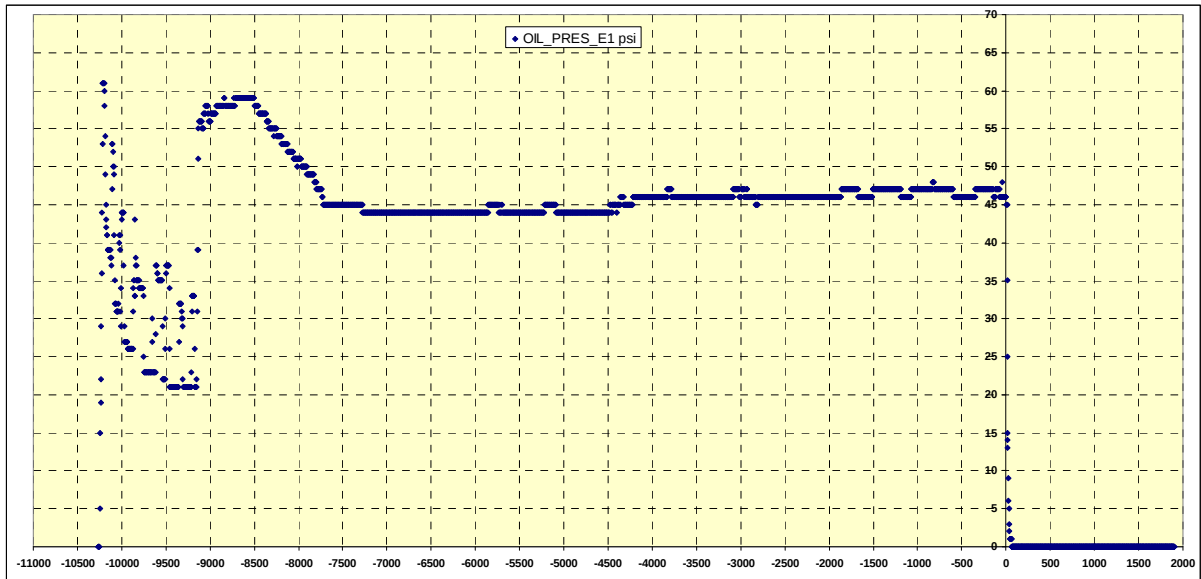
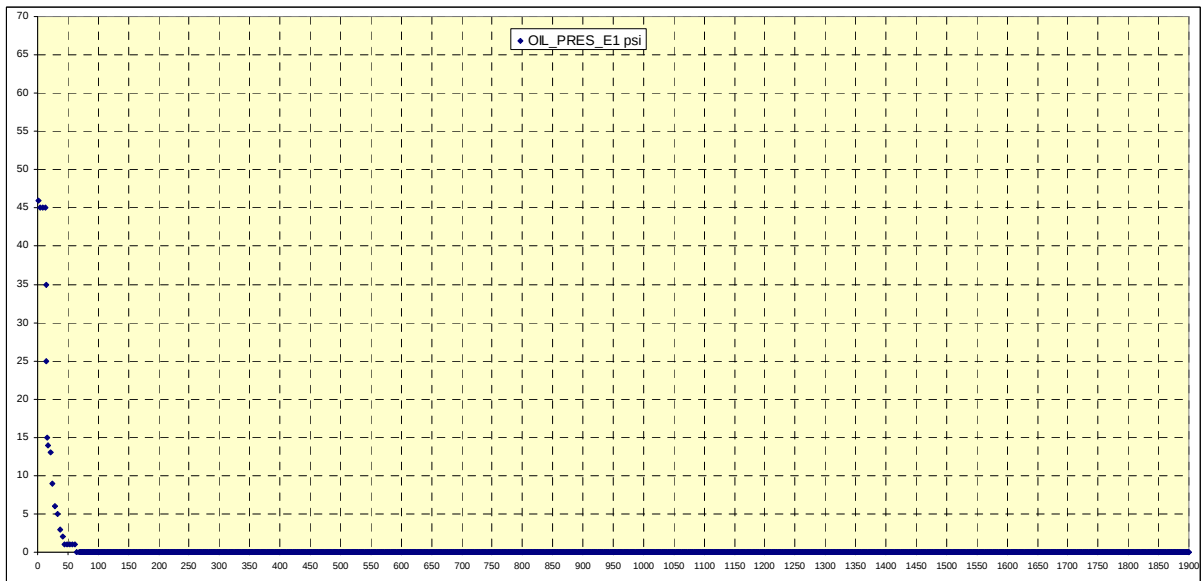
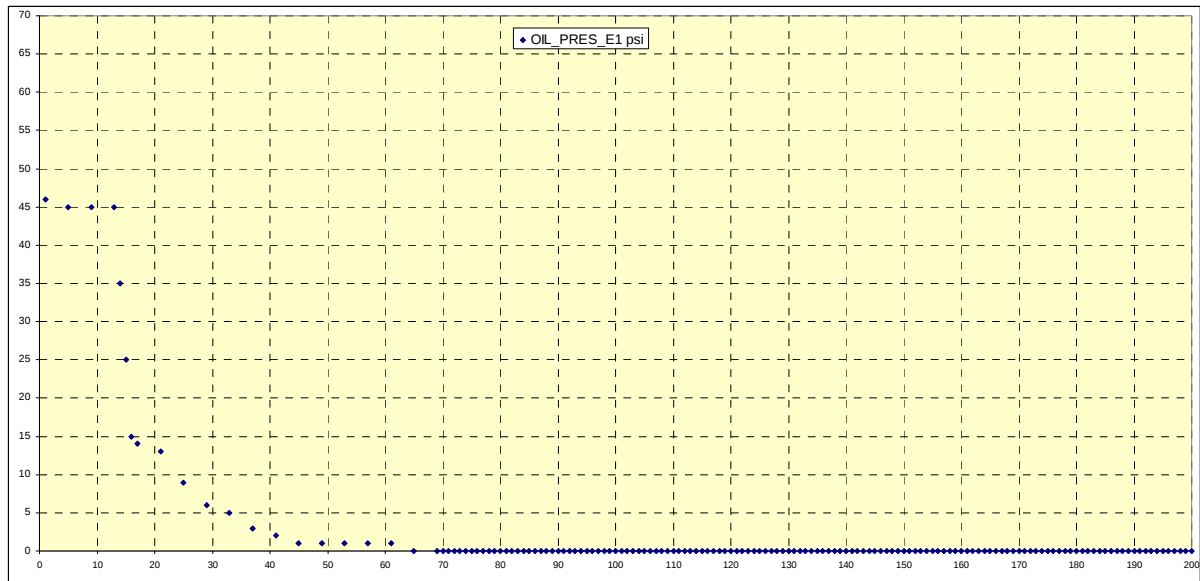
### 3. Oil press engine #1:

The oil pressure was showing about 45 psi during cruise. The pressure started dropping at almost 13 seconds. The oil pressure continued decreasing until it reached zero psi at about 65 seconds.

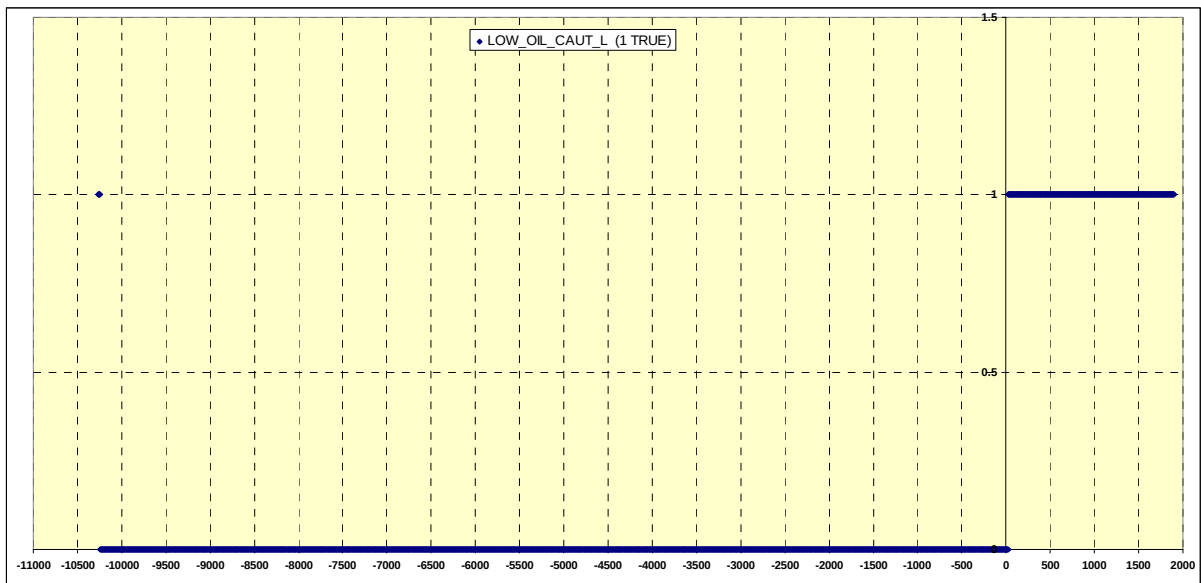
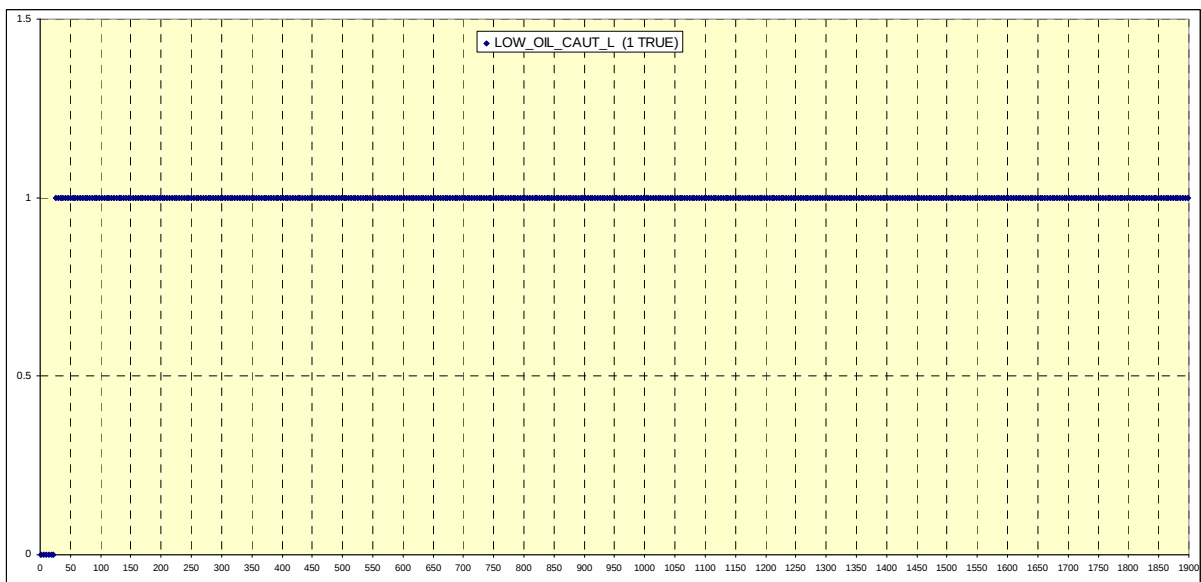
## 5. Oil low press caution (discrete) engine #1:

Oil Low Press caution came on at about 26 seconds and remained "On" the whole remaining time.

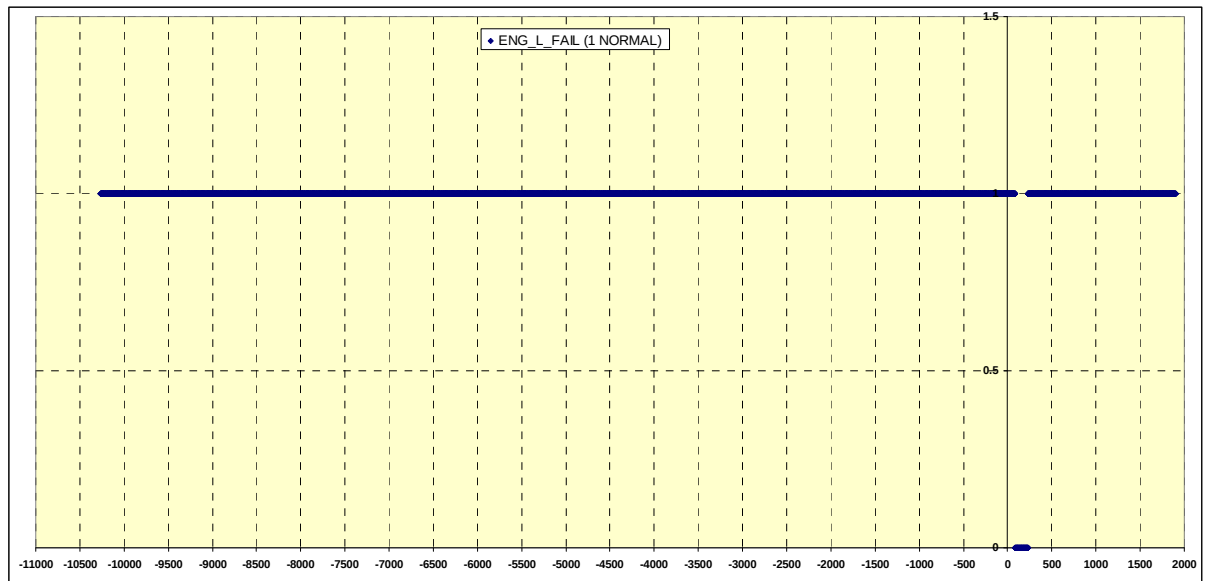
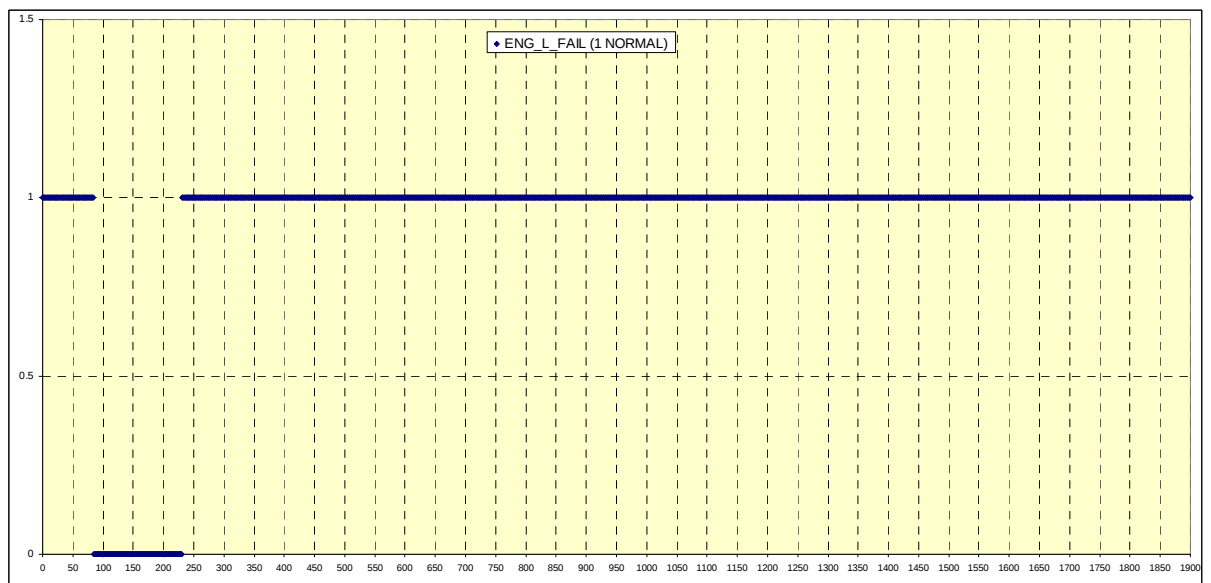
## 7. Engine Fail Warning (discrete) engine #1:

An Engine Fail warning appeared at almost 86 seconds and remained there until 230 seconds time, and then it vanished up to the end of recording (1900 seconds)

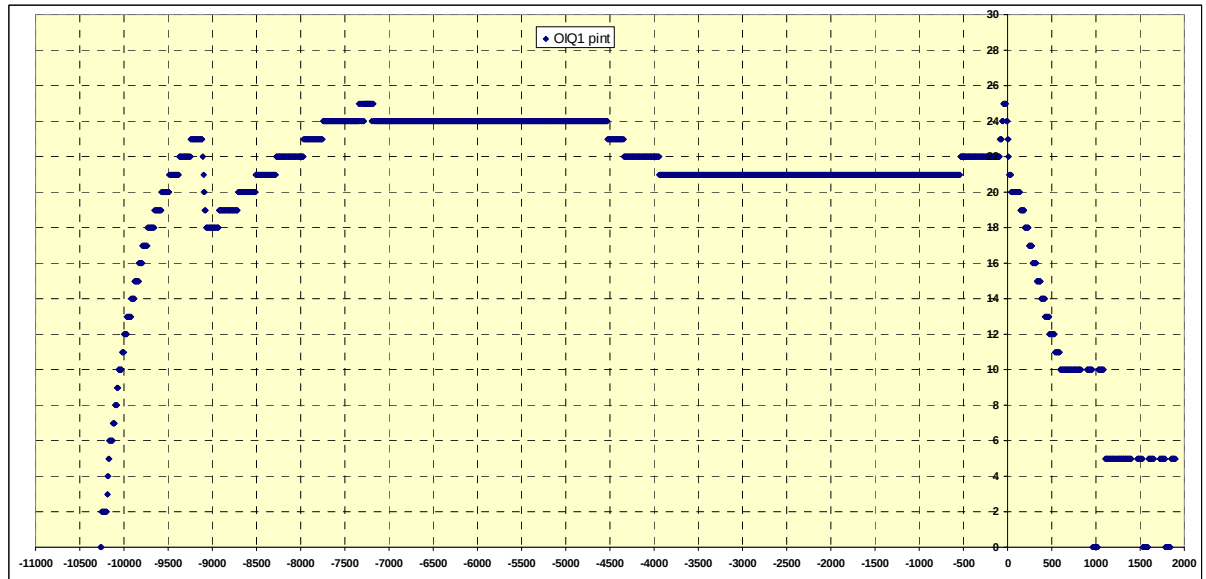
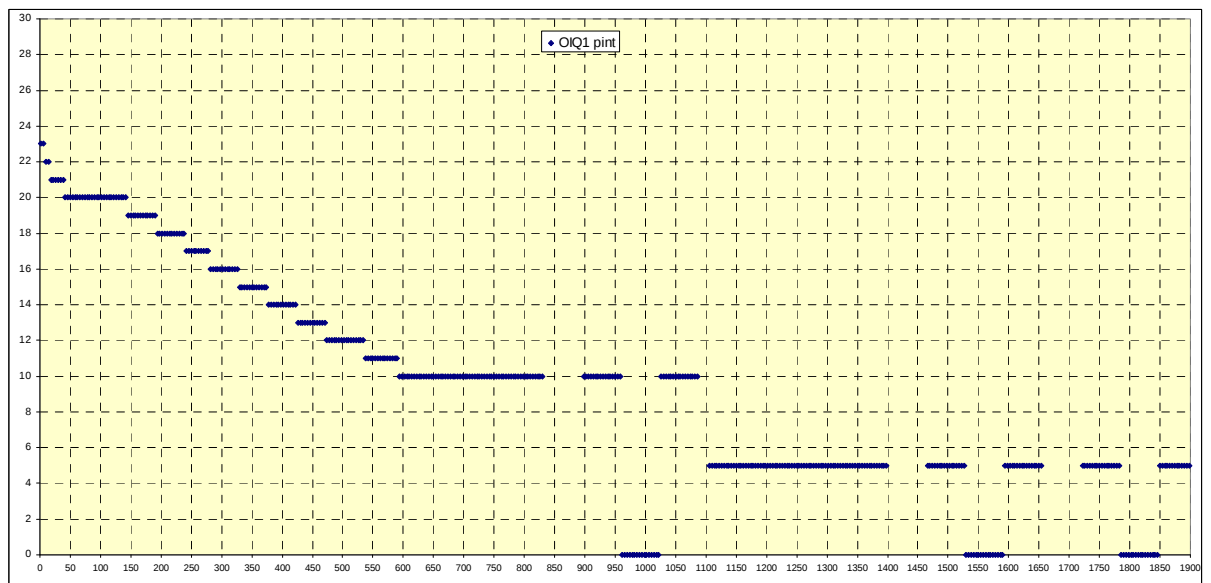
## 9. Oil Quantity Engine #1:

The oil quantity showed a value of about 23 US Quarts at 0 time. Immediately after that the oil quantity starts dropping continuously until it reached about only 10 US Quarts at almost 594 seconds. Starting from almost 962 seconds it started fluctuating between 0 and 5 US Quarts.

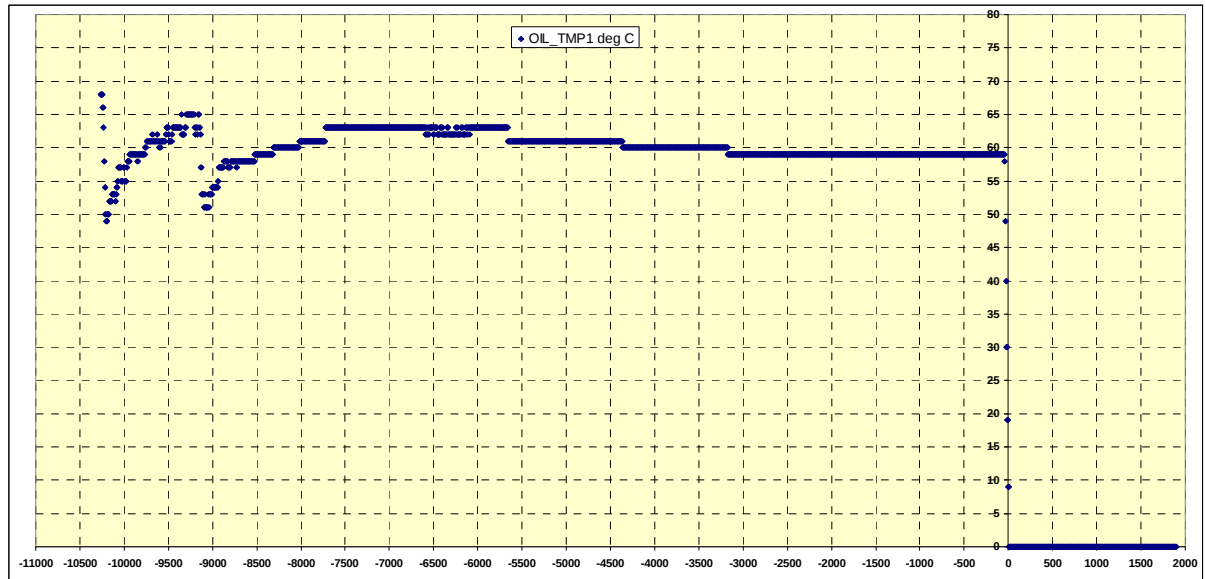
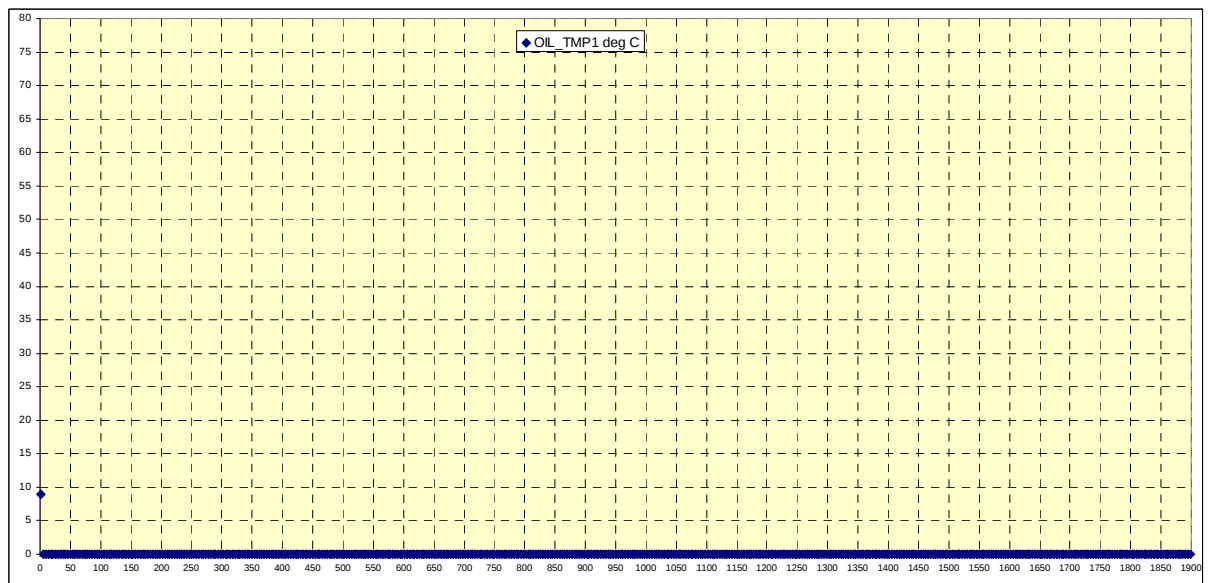
## 11. Oil temp Engine #1:

Oil temp was showing about 59 degree Celsius during cruise. Oil temp suddenly dropped to about 0 at almost -46 seconds

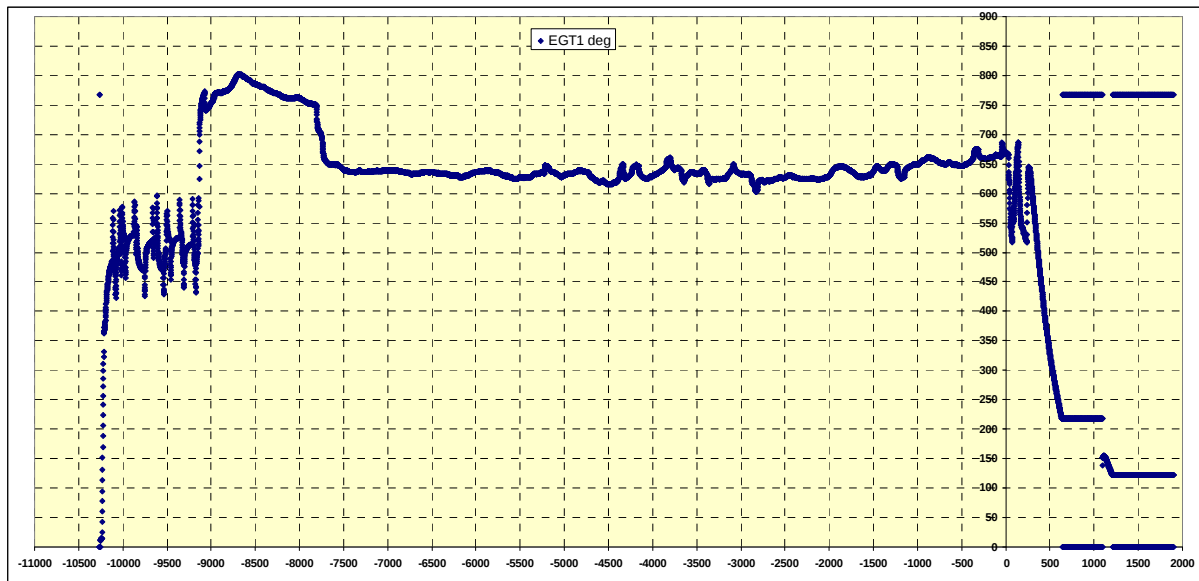
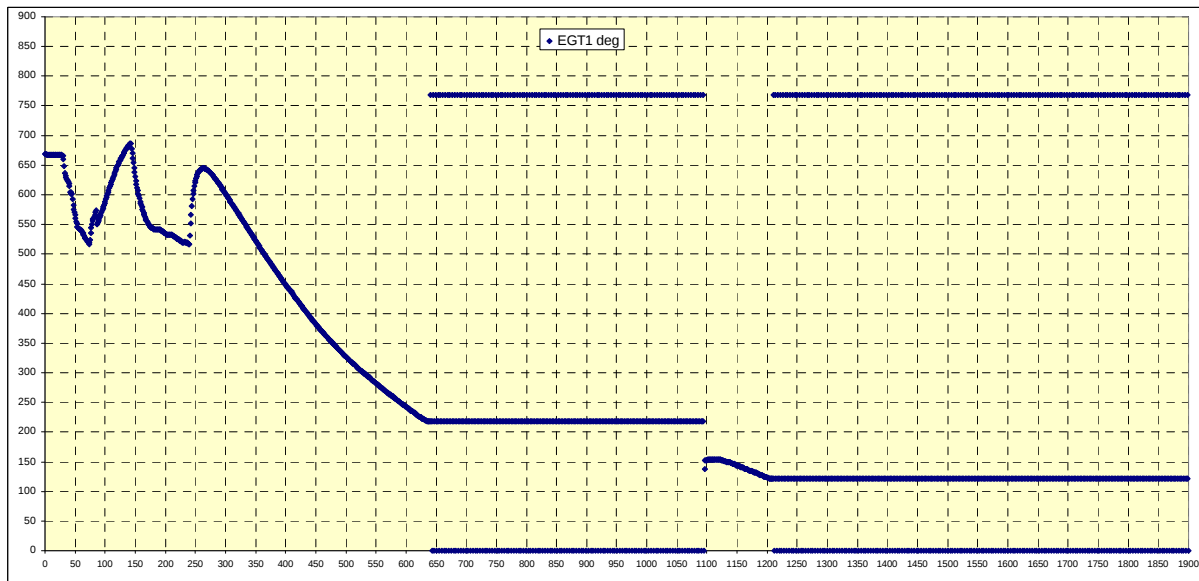
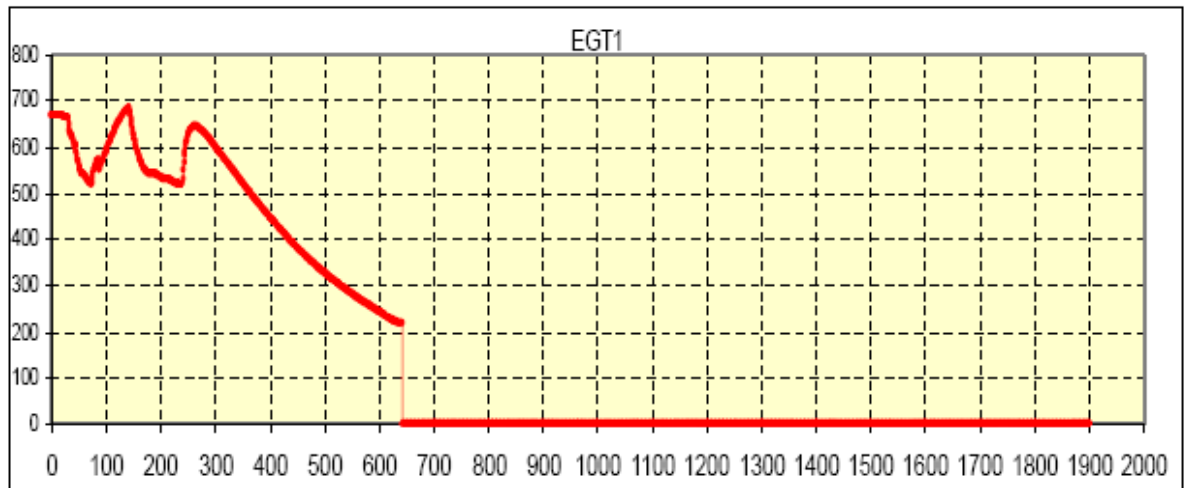
13. EGT Engine #1:

The EGT indication showed about 668 degree Celsius at 0 time (cruise). It dropped to almost 517 degree Celsius at about 74 seconds. It continues varying between almost 520 to 650 degree Celsius before dropping down to about 210 degree Celsius at about 630 seconds.

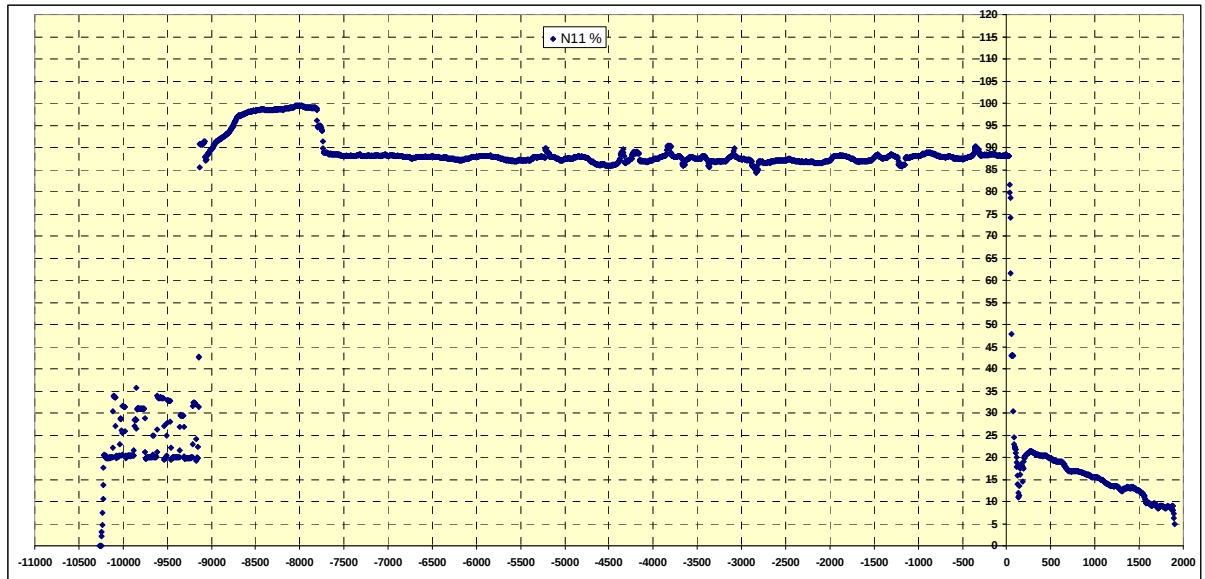
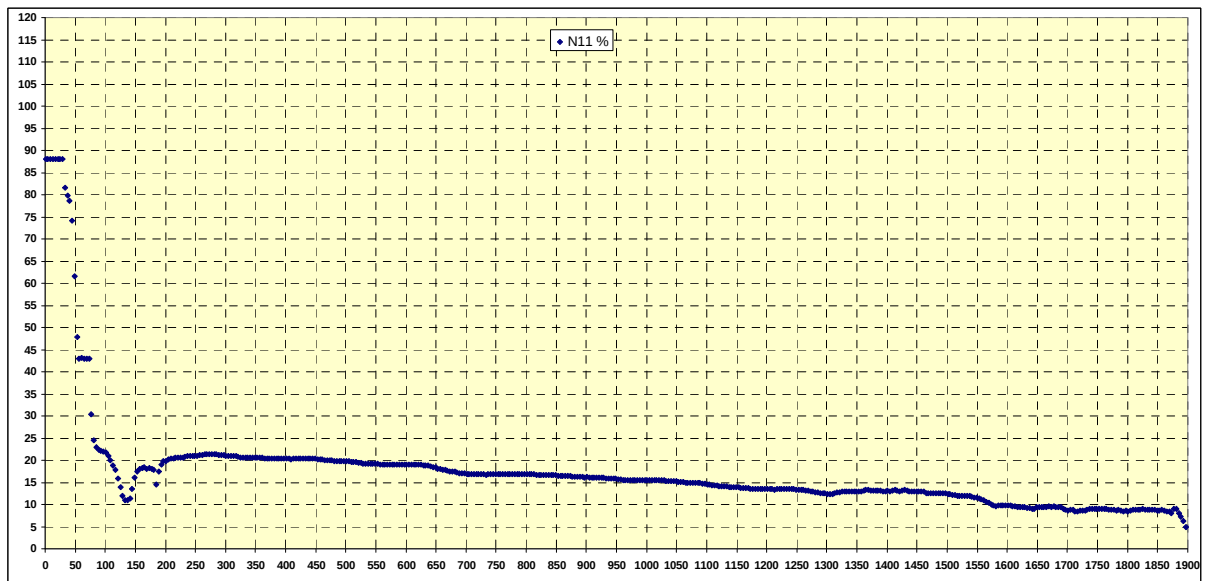
### 19. N1 Engine #1 (N11):

N11 was showing 88 % at zero second (cruise). At almost 29 seconds, the N11 dropped sharply reaching only about 11% at about 133 seconds. N11 varied again from about 20 % up to zero at the end of recording

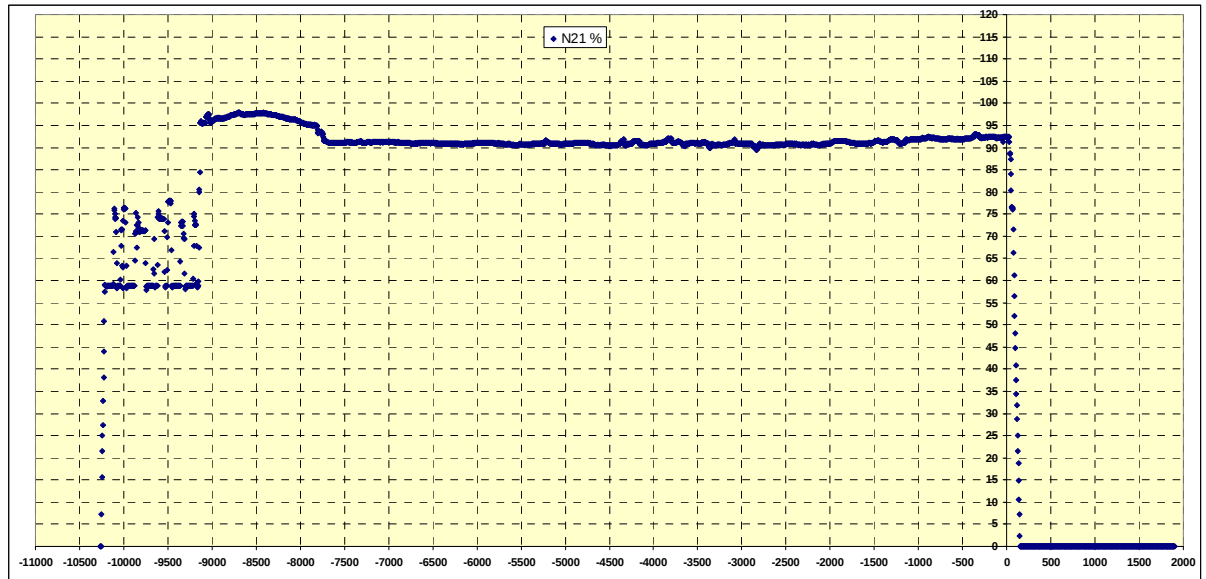
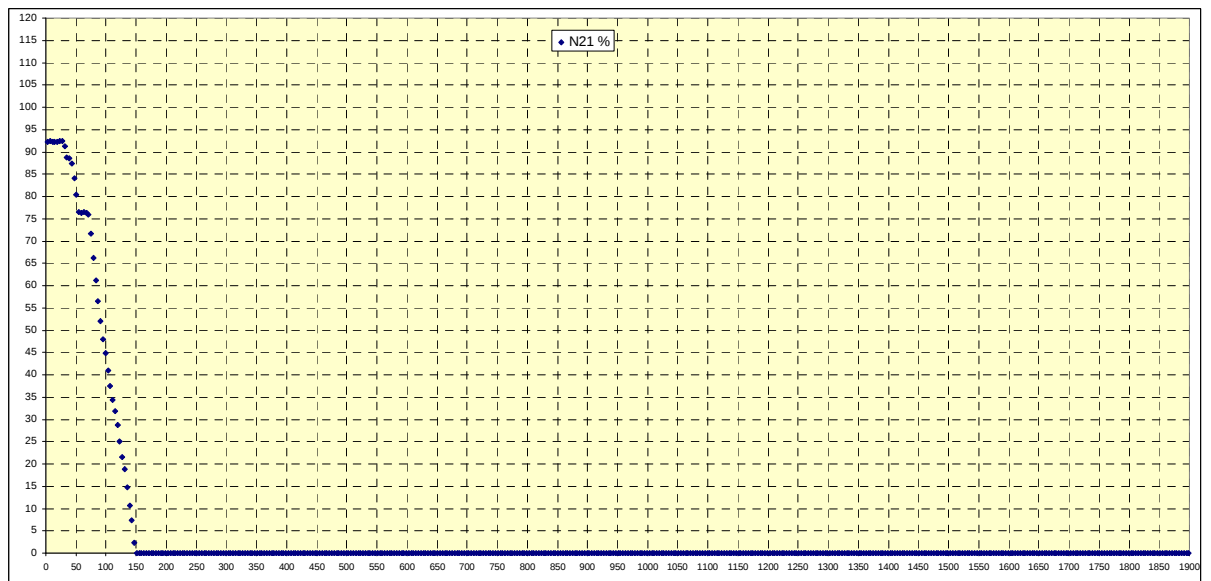
## 21. N2 Engine #1 (N21):

N21 was showing 92 % at zero second (cruise). At almost 27 seconds, the N21 dropped sharply reaching 0% at about 151 seconds.

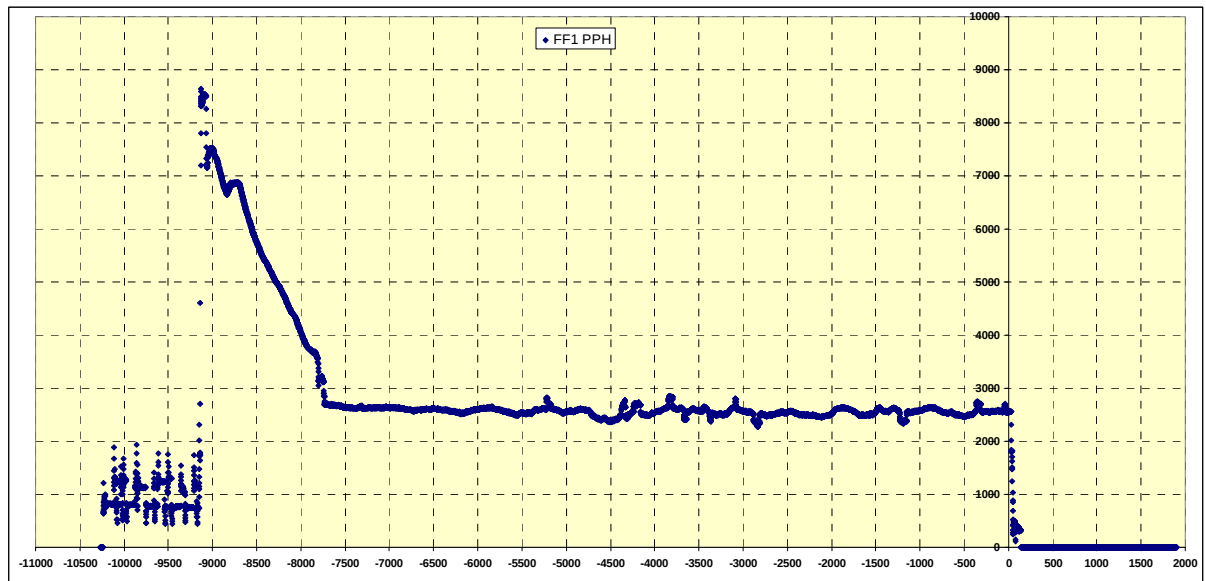
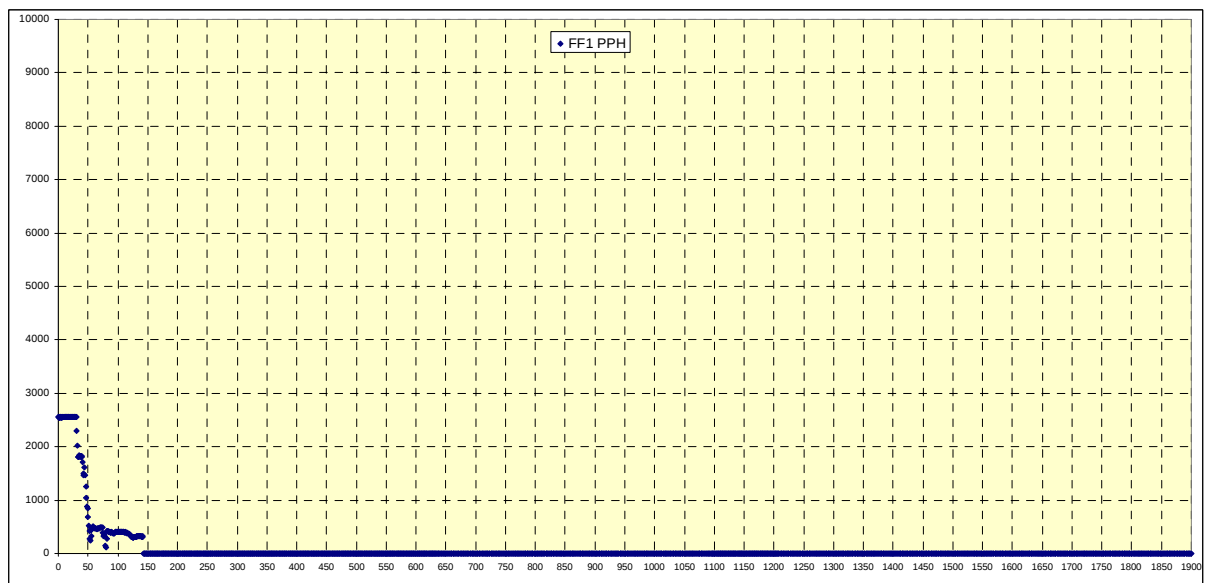
### 23. Fuel Flow Engine #1 (FF1):

FF1 was about 2560 kg/hr during cruise. At almost 30 seconds, the FF1 dropped sharply reaching zero at almost 143 second (Start lever was moved to cut off at 230 seconds)

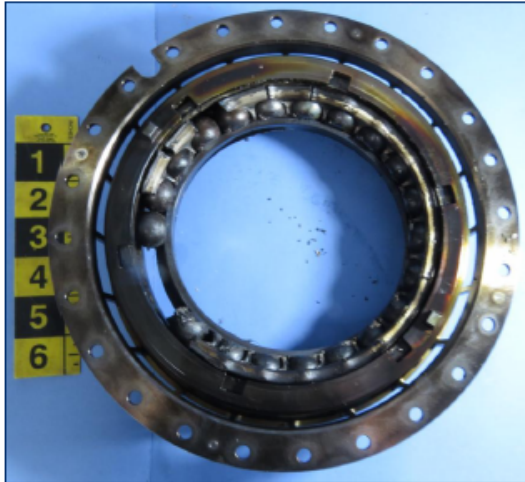
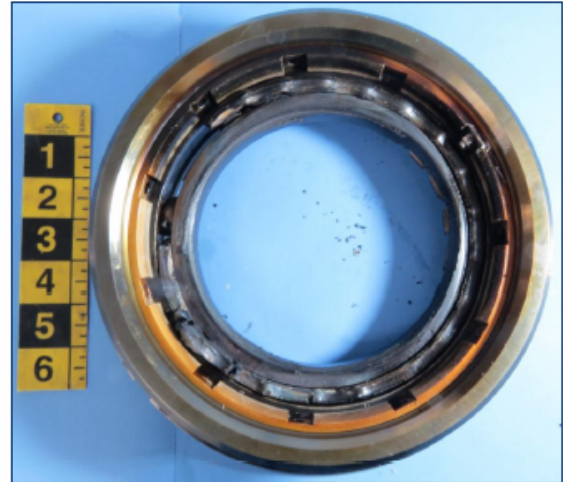
## Incoming Condition

- CFM56-7 engine delivered on March 1, 2007
- UER on Nov 7, 2013 due to IFSD on 10/26/2013
  - TSN/CSN: 13,972/7,127
  - Oil filter analysis: None found in SR
- Engine sent to GE Wales (shop) for Repair
- Bearing sent to GE PSE for investigation
- Engine has one (1) prior shop visits
  - *Nov 22, 2012 – China Eastern returned engine to lease company. However, #3 bearing was not touched per FSE SR attachment.*

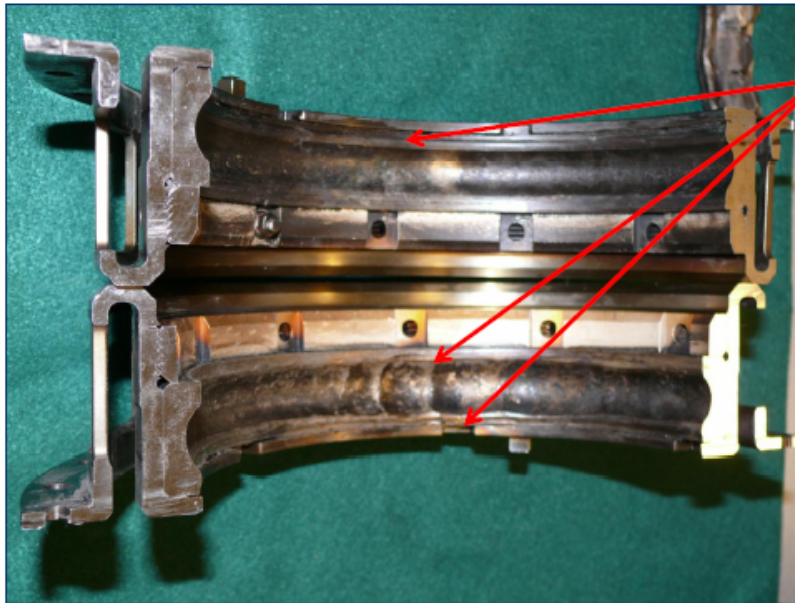
## Outer Race

Evidence of wear (seen as grooves) on both shoulders. This is caused by hard particles embedding in silver plate of cage and acting as a grinding wheel or cutting tool on outer race

Deposits and smearing of molten rolling element material in raceway  
No evidence found of any outer race spallation

Most likely root cause is shoulder wear induced by environmental hard particle debris.

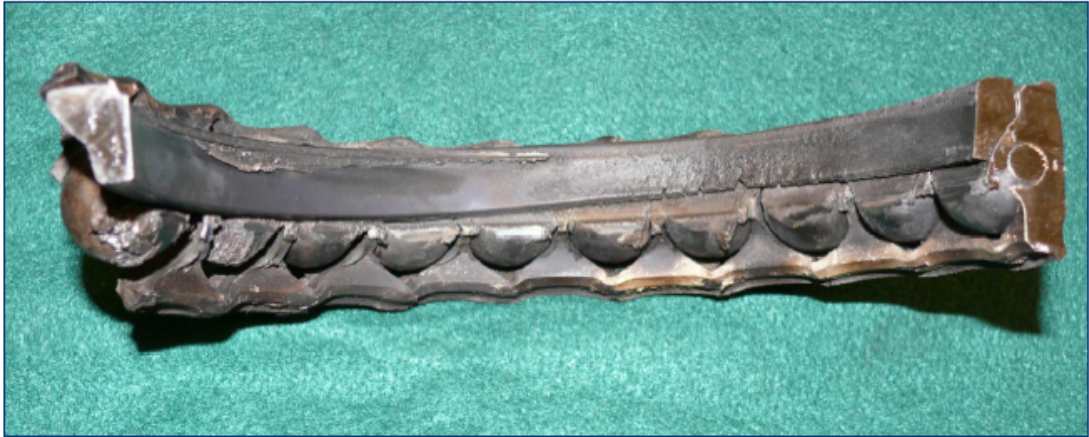
## Inner Races

Distortion and extrusion of forward inner race due to the balls sliding and adhering to the surface indicates that the HP rotor was aft loaded at time of failure.

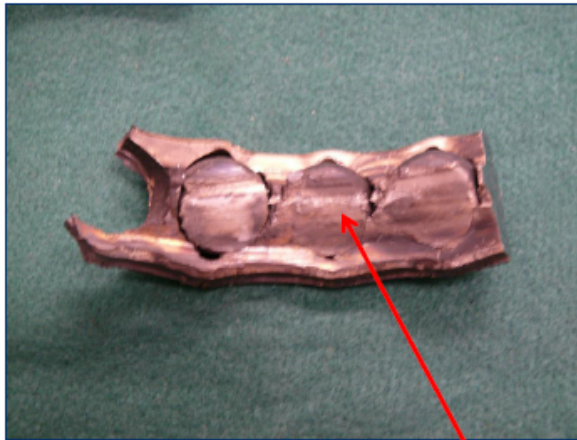
## Balls, Cage

Cage shows circumferentially uniform heat distortion. Multiple cage pockets fractured and liberated.

All cage side rails showed cracks or crack initiation with thermally induced distortion

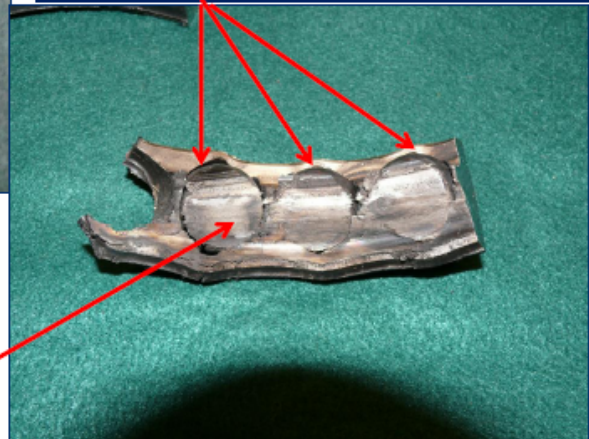
All balls exhibit sliding wear flats. This indicates that rolling elements seized during failure and did not continue to rotate.
