التقرير الفني

عن حادث الطائرة الهليكوبتر المسجلة SU-CAU من طراز
BELL 212 والتابعة لشركة خدمات البترول الجوية PAS
اثناء ادارة محركاتها على مهبط مطار راس شقير ووفاء احد العاملين

يوم ٢٠١٣/٧/١٠

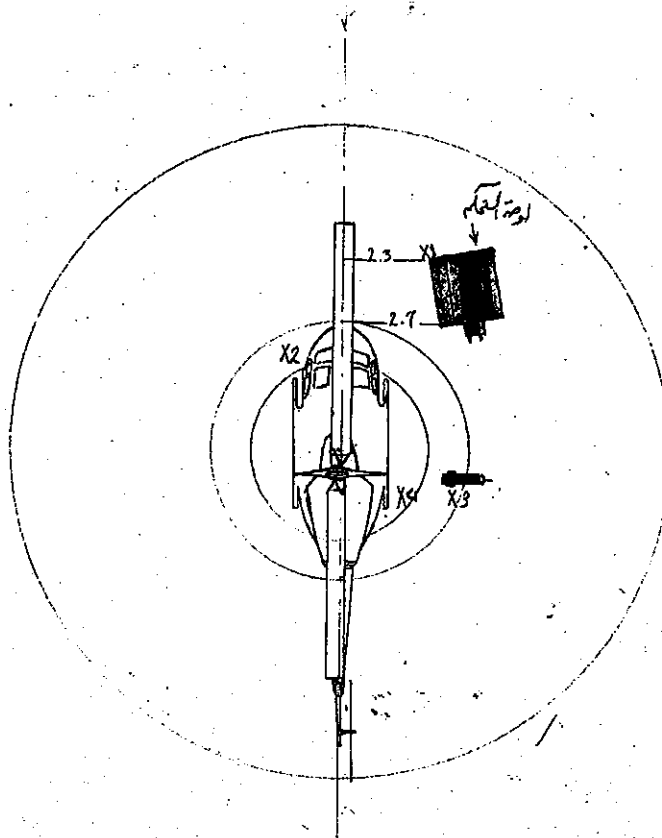
- تم معاينة موقع الحادث بمطار راس شقير عند حدوث الواقعة مباشرة وقد تبين من المعاينة مايلى :
 - وجدت الطائرة SU-CAU من طراز BELL212 موضوع الواقعة متوقفة على المهبط رقم ٣ بمطار راس شقير .
 - وجد اثار دماء على الارض بجانب وحدة APU التى كان المساعد الفنى / [REDACTED] المتوفى مسئول عن توصيلها بالطائرة لادارة محركاتها .
 - وجدت طفاية الحريق بجانب المحرك رقم ٢ الذى تم ادارته وإيقافه عقب وقوع الحادث مباشرة .
 - وجد الحبل الخاص بطرف الريشة الرئيسية الثانية للمروحة الذى كان يمسكها مساعد الفنى / [REDACTED] .

- توفى المساعد الفنى / ■■■ اثر اصطدام الجانب الايمن من مقدمة الرأس بطرف ريشة المروحة الرئيسية للطائرة موضوع الحادثة وتبلغ سرعة دوران المروحة عند الوضع الخامل IDLE نحو ٨٠٠ لفة/دقيقة .
- وقد ادت شدة ارتطام المروحة الناجمة عن وزنها وسرعتها برأس العامل المتوفى الى احداث اصابة جسيمة بها ادت الى وفاته .

- حركة المروحة كتأثير لقوى المحرك فى بدايه الدوران مع إنخفاض مستوى ارتفاع المروحة ليكون فى نفس مستوى رأس المساعد الفنى ادى الى اصابته بالرأس ووقوع الحادث .
- سرعة الرياح التى وصلت الى ٣٢ عقده قد قللت من ارتفاع طرف TIP ريشة المروحة الرئيسية عن الارض اثناء دورتها الأولى مما جعلته يصل الى مستوى ارتفاع رأس المساعد الفنى .
- تحرك العامل اثناء ادارة المحرك ودخوله فى منطقة الخطر HAZARD AREA .

- توصى لجنة التحقيق بقيام سلطة الطيران المدني باتخاذ اللازم نحو قيام شركة خدمات البترول الجوية PAS بعمل الاتي :-
- ٤-١- القيام باصدار التعليمات التي تنظم العمل تحت الطائرة والتي تكفل سلامة العاملين.
 - ٤-٢- قيام الشركة بتدريب العاملين على إجراءات العمل تحت الطائرة والتأكد من الإلتزام بها.
 - ٤-٣- القيام بوضع نظام للتأكد من اللياقة الطبية للعاملين في خدمة الطائرات سواء من العاملين الدائمين بالشركة او العمالة المؤقتة التي يتم الاستعانة بها من خارج الشركة.
-
