# Final Report

Replacing Engine #1 installed on the aircraft Boeing 737-800

Registered as UR-CLR

Aircraft Accident Investigation Central Directorate

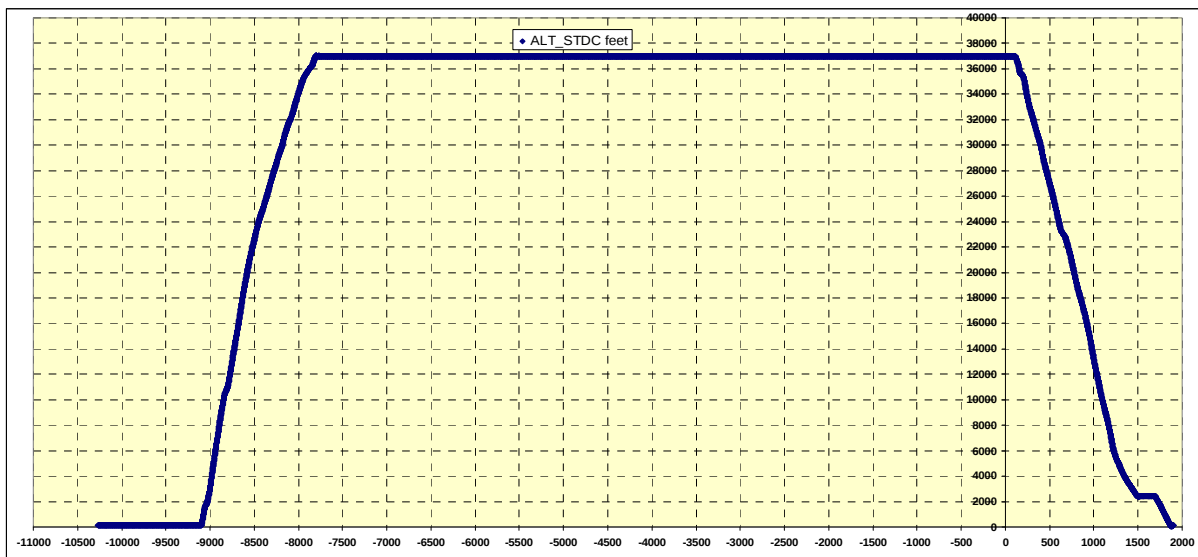
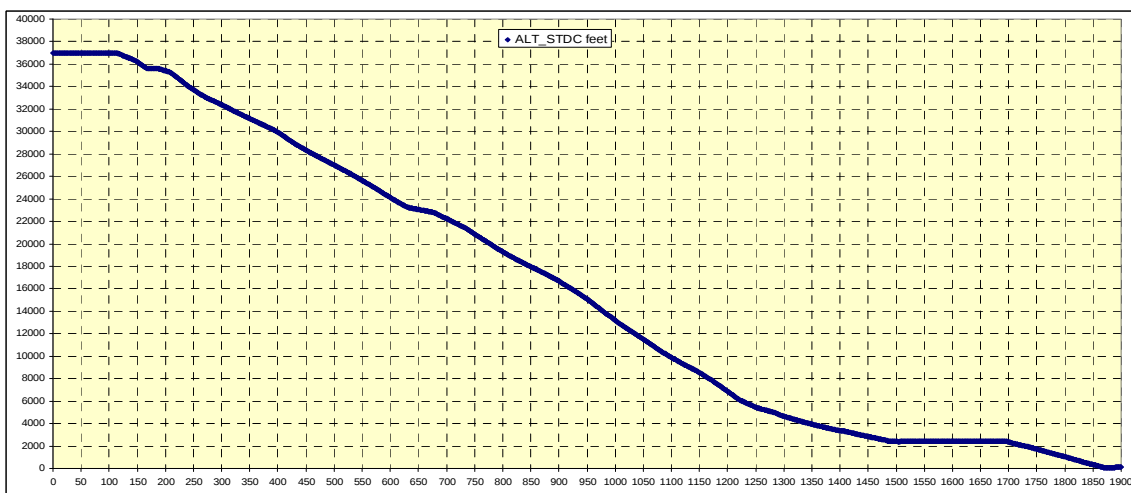
### 1. Pressure Altitude:

- The Graph shows that the aircraft was cruising at an altitude of 37000 ft, the aircraft started its descent at the time 117 seconds, continued its descent up to 1900 seconds. (about 1790 second equivalent to about 29 min, 50 seconds)

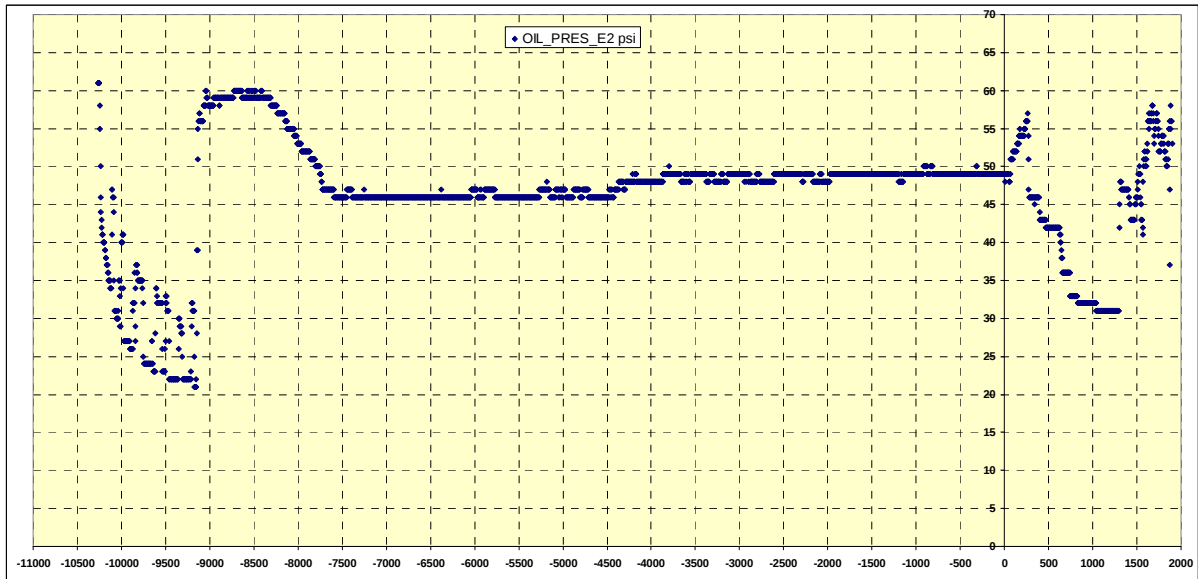
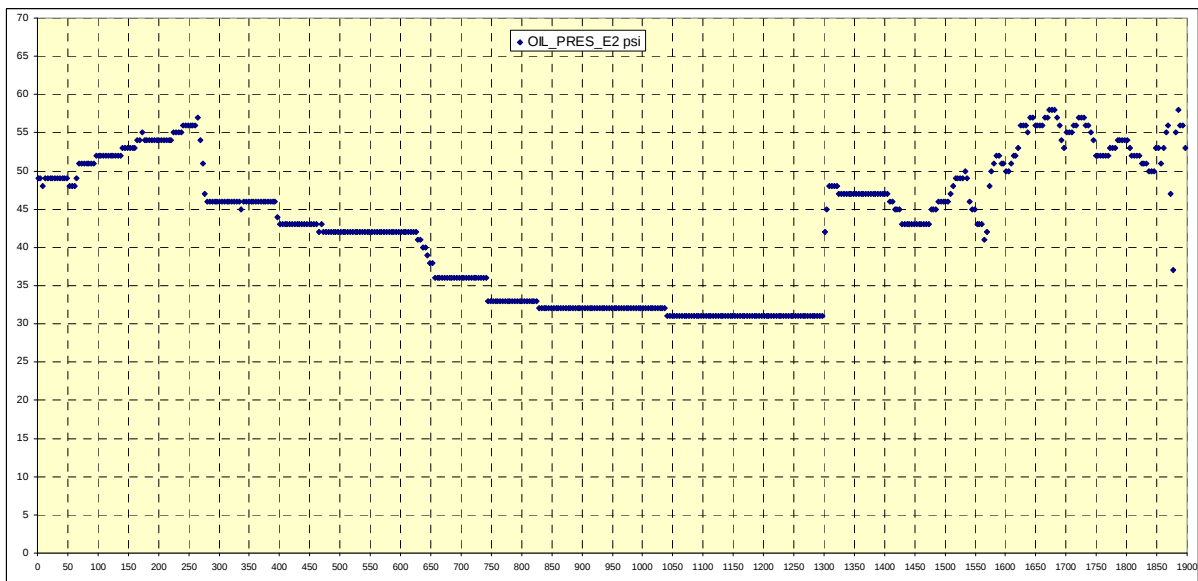
#### 4. Oil press engine #2:

The oil pressure was showing about 49 psi at 0 seconds (cruise). The pressure showed variation during descent, with a maximum value of about 58 psi and a minimum value of about 31 psi.

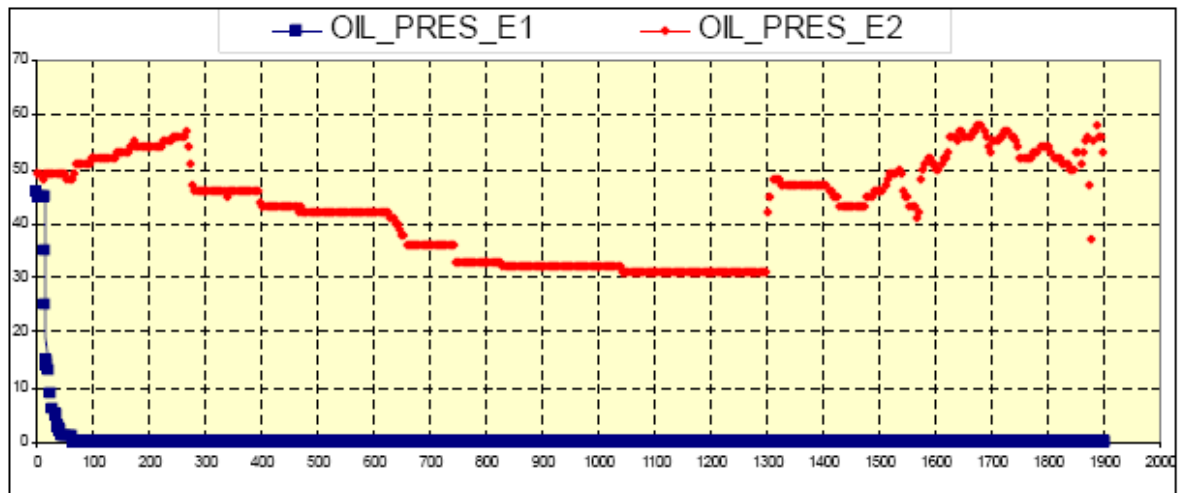
Combined oil press graph (engine #1 and engine #2)

The oil pressure was showing about 45 psi during cruise. The pressure started dropping at almost 13 seconds. The oil pressure continued decreasing until it reached zero psi at about 65 seconds.

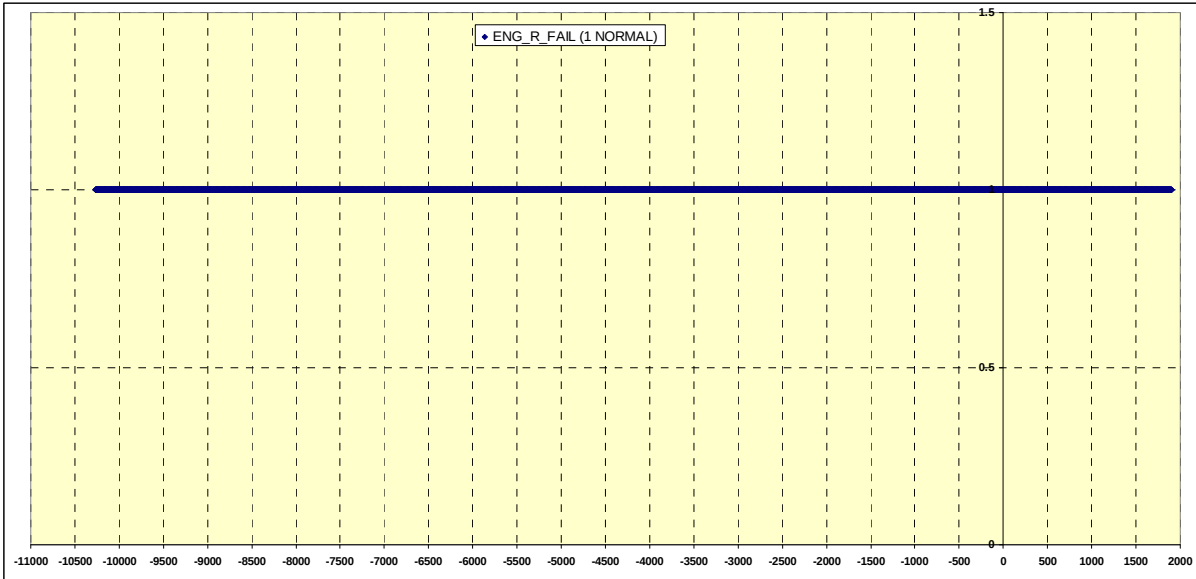
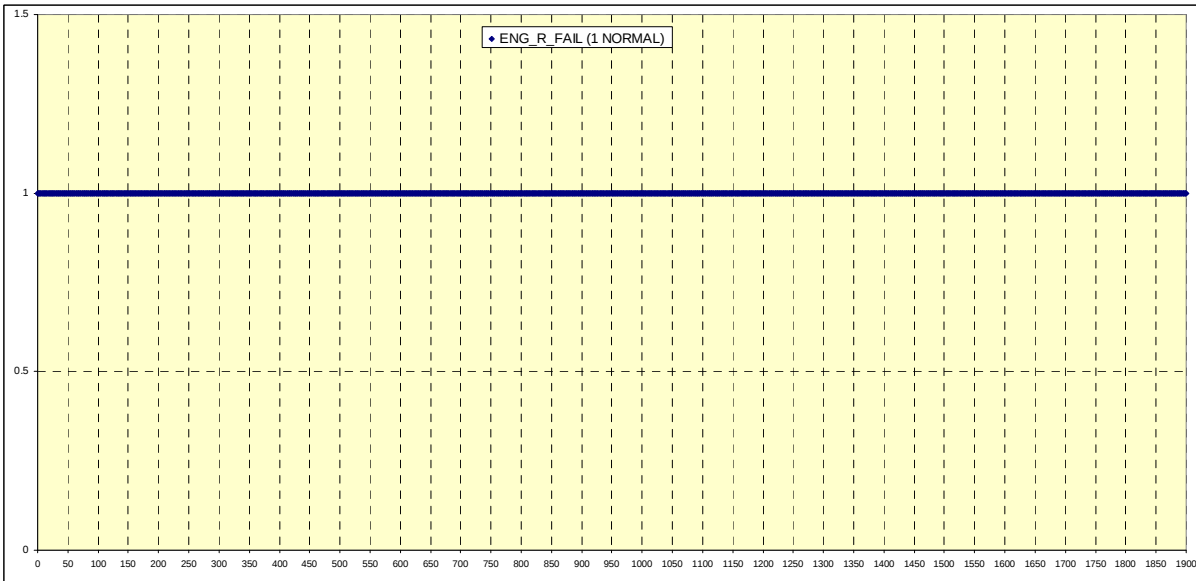
8. Engine Fail Warning (discrete) engine #2:

Engine Failure Warning did not show up

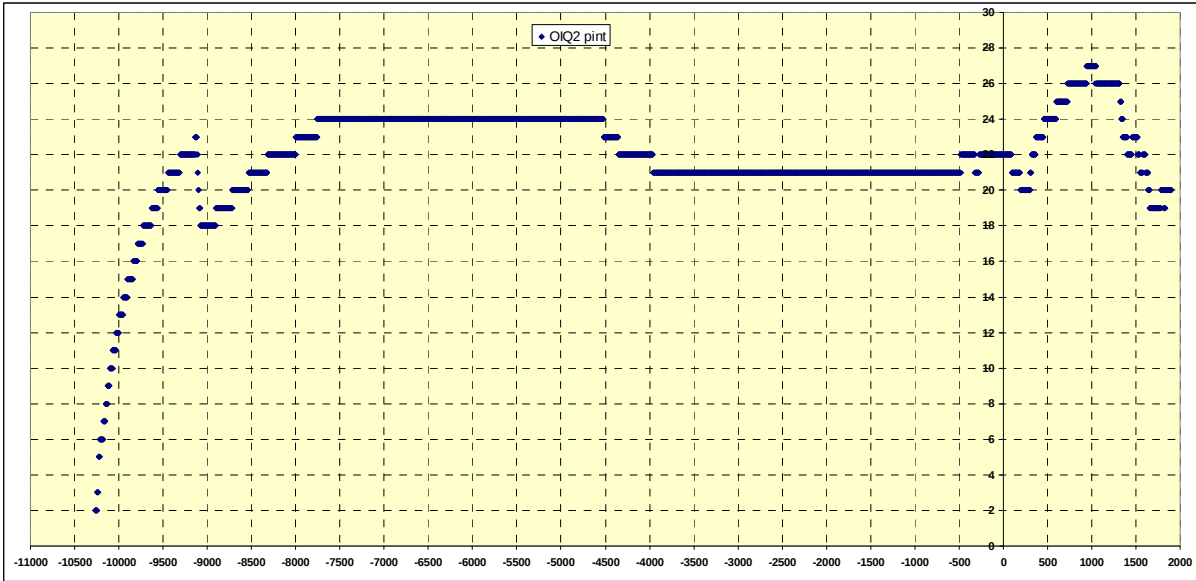
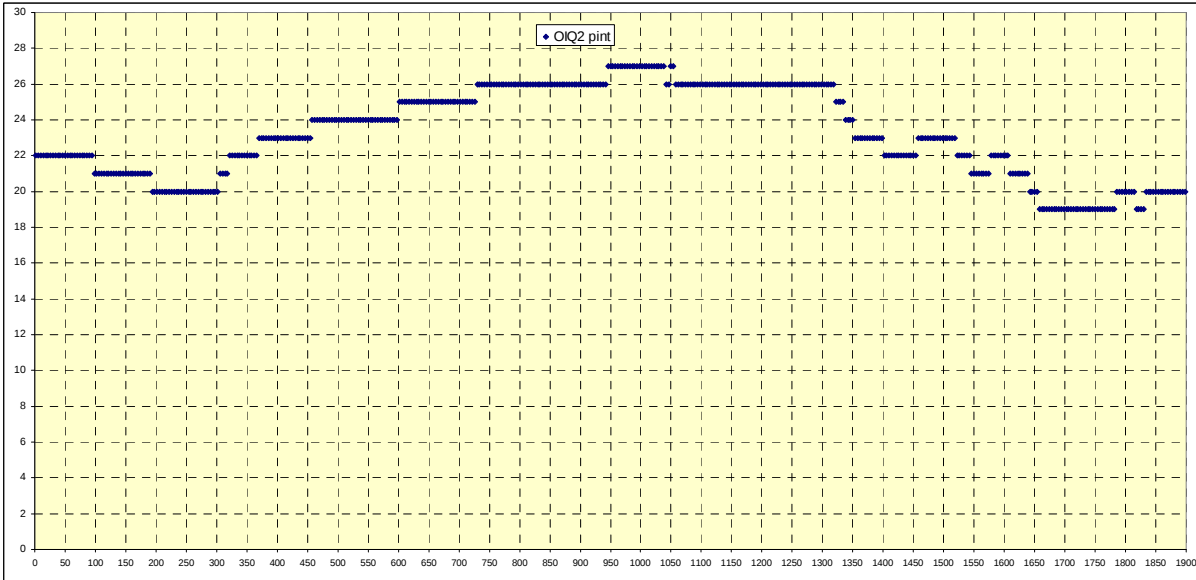
10. Oil Quantity Engine #2:

The oil quantity showed values between about 27 US Quarts and about 19 US Quarts.

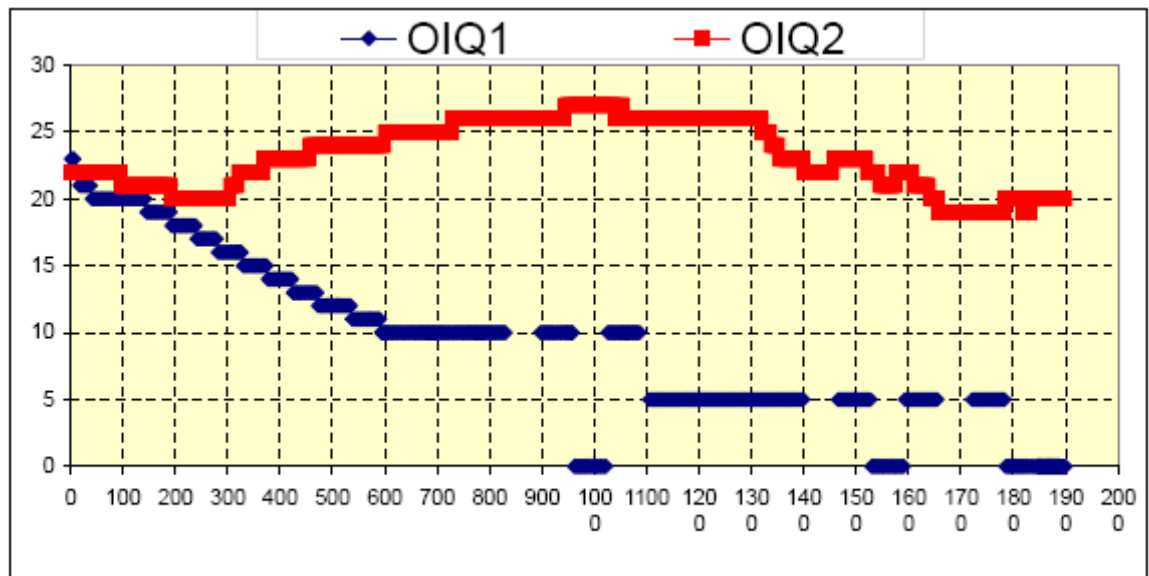
Combined oil quantity graph (engine #1 and engine #2)

The oil quantity showed a value of about 23 US Quarts at 0 time. Immediately after that the oil quantity starts dropping continuously until it reached about only 10 US Quarts at almost 594 seconds. Starting from almost 962 seconds it started fluctuating between 0 and 5 US Quarts.

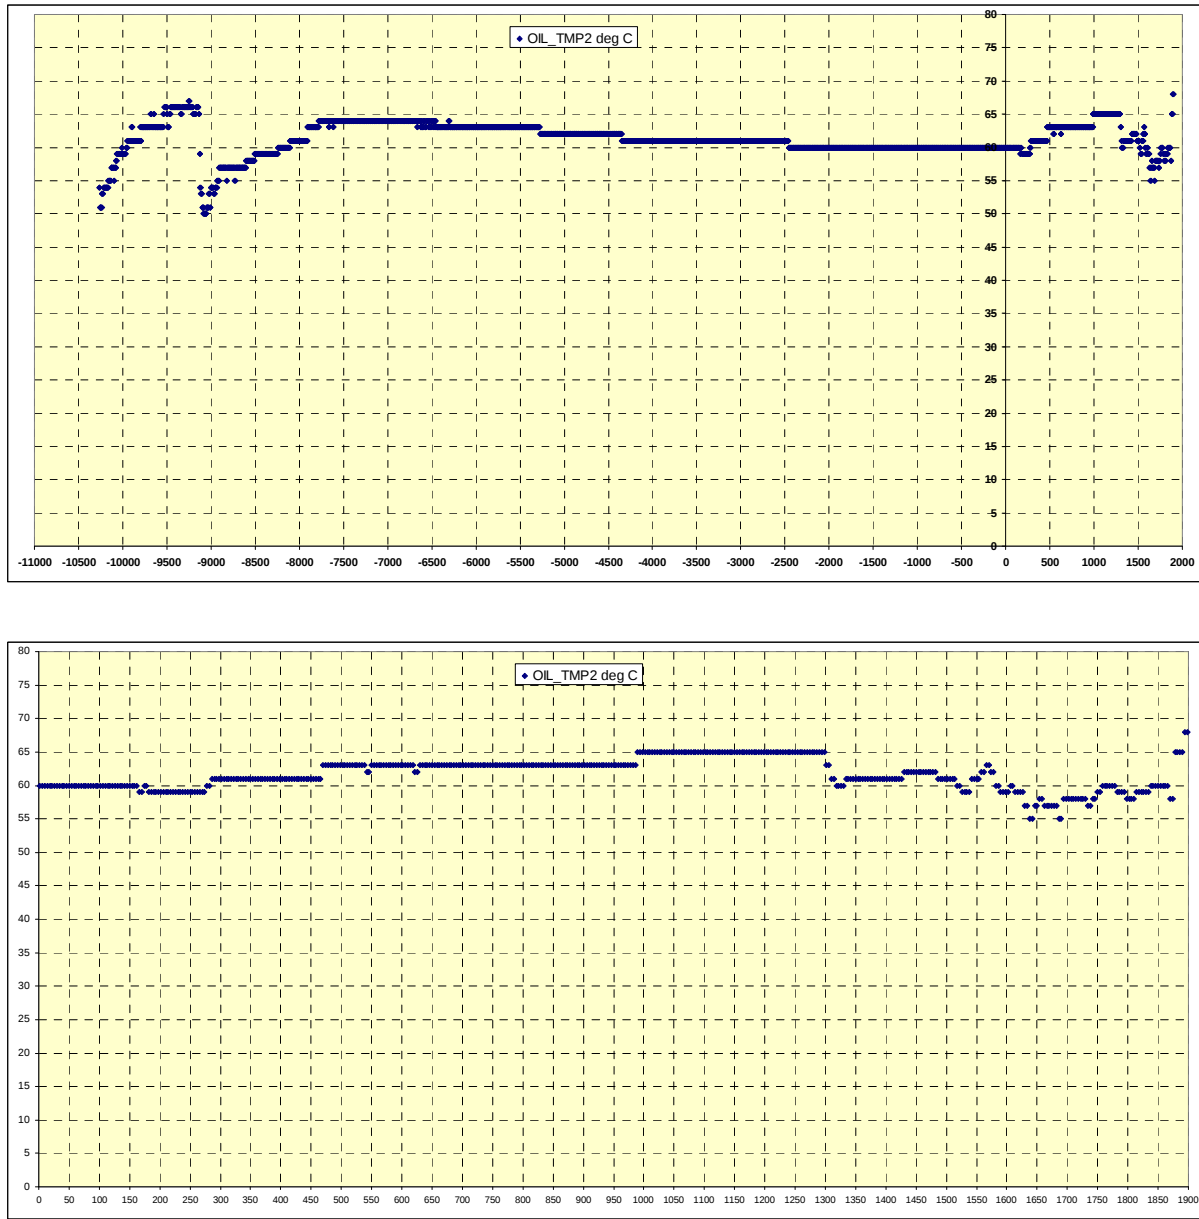
12. Oil temp Engine #2:

Oil temp did not show abnormal behavior.

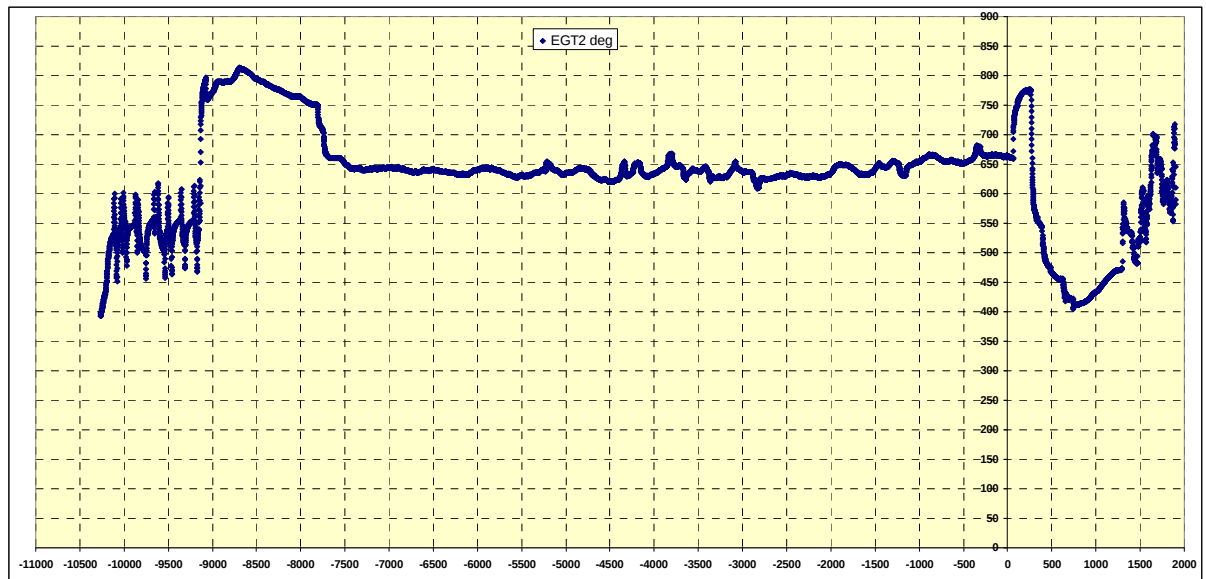
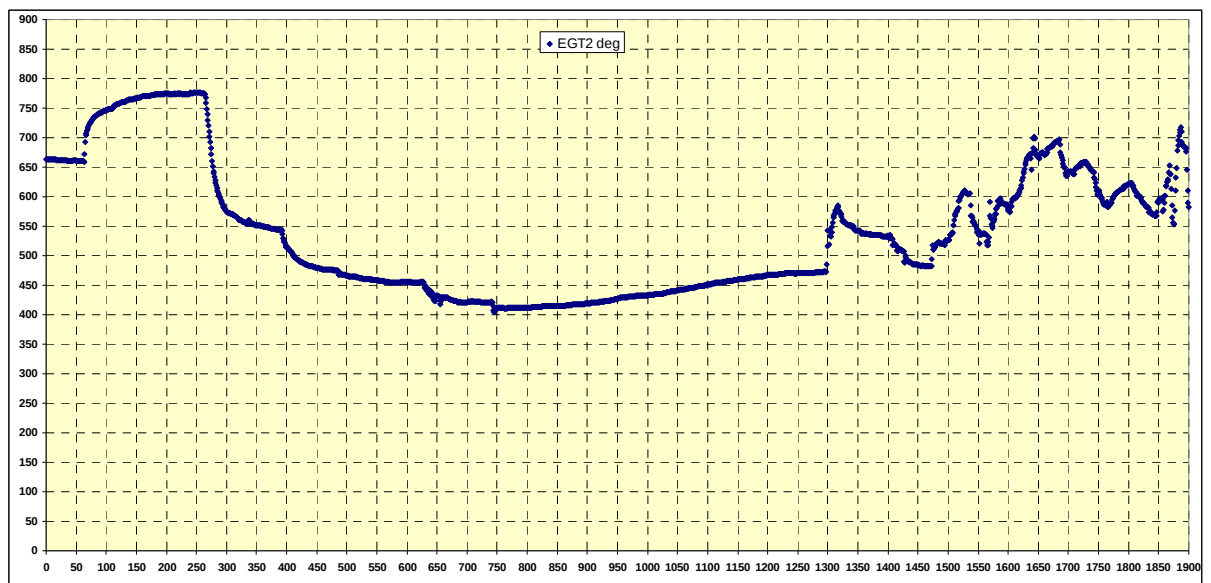
#### 14. EGT Engine #2:

The EGT was varying during the descent. EGT did not show abnormal behaviour.

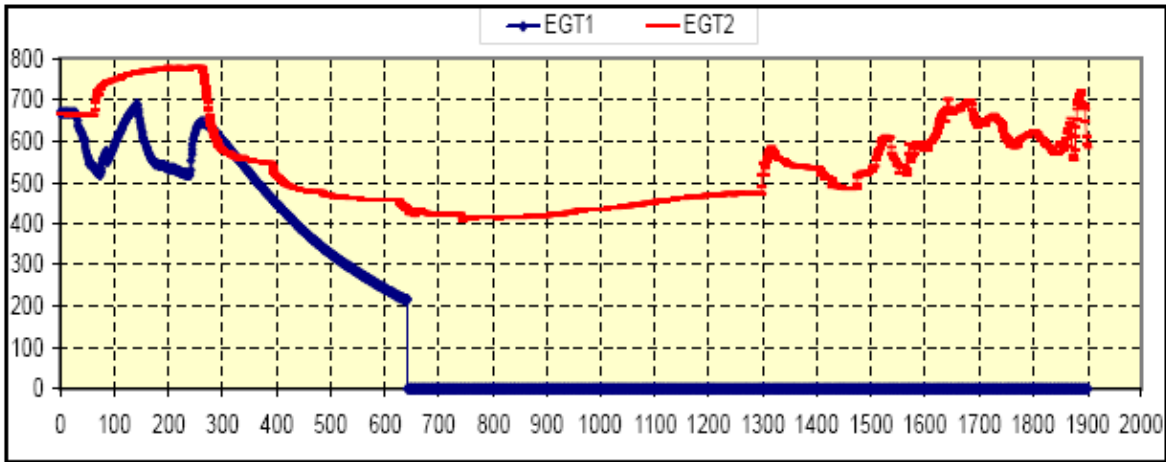
Combined EGT graph (engine #1 and engine #2)

The EGT indication showed about 668 degree Celsius at 0 time (cruise). It dropped to almost 517 degree Celsius at about 74 seconds. It continues varying between almost 520 to 650 degree Celsius before dropping down to about 210 degree Celsius at about 630 seconds.

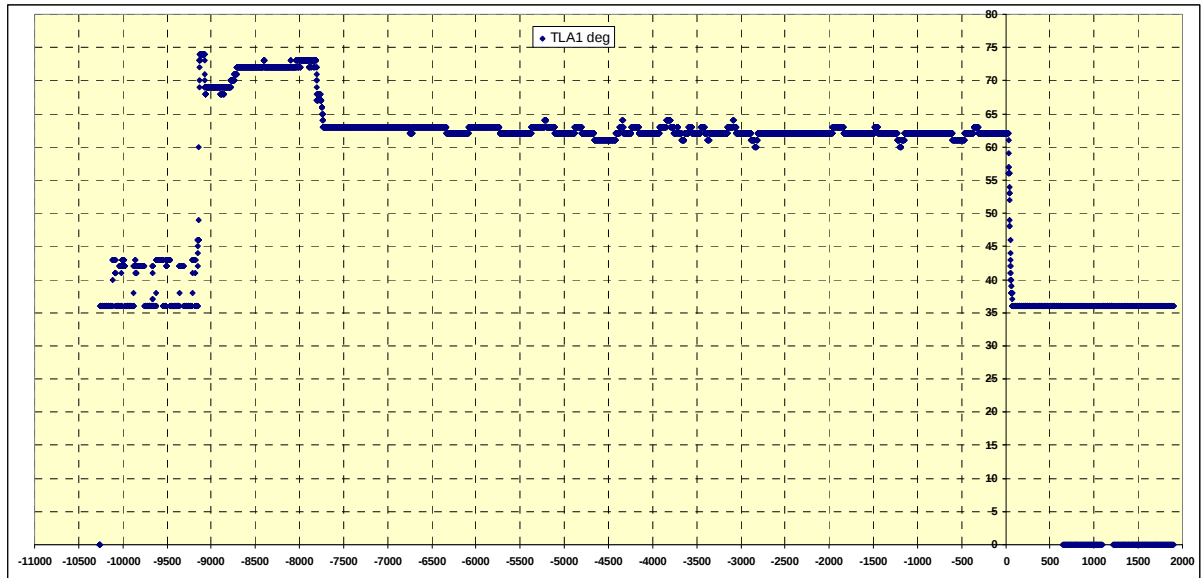
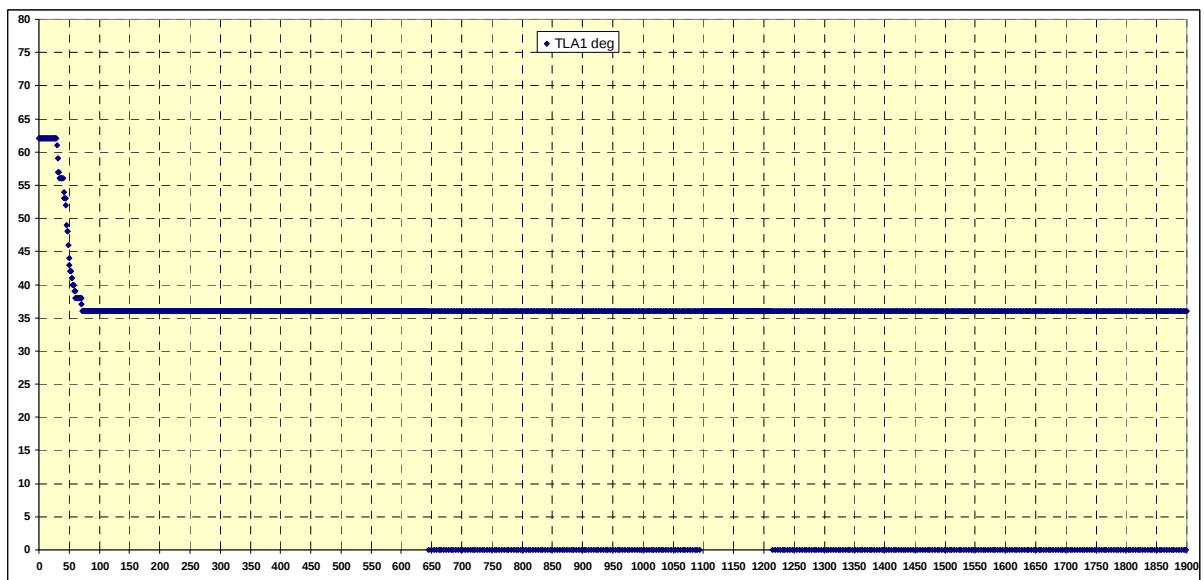
## 15. TLA Engine #1:

At 0 seconds (cruise), the TLA for engine #1 showed about 62 degree. At almost 29 seconds, the throttle lever started being retarded showing about 36 degrees ( forward idle position) at about 72 seconds<sup>1</sup>. The throttle lever remained at this position up to the end of recording.

<sup>1</sup> The fwd idle reverse as shown in the B737-800 manual is 36-38 degrees at the EEC resolver.

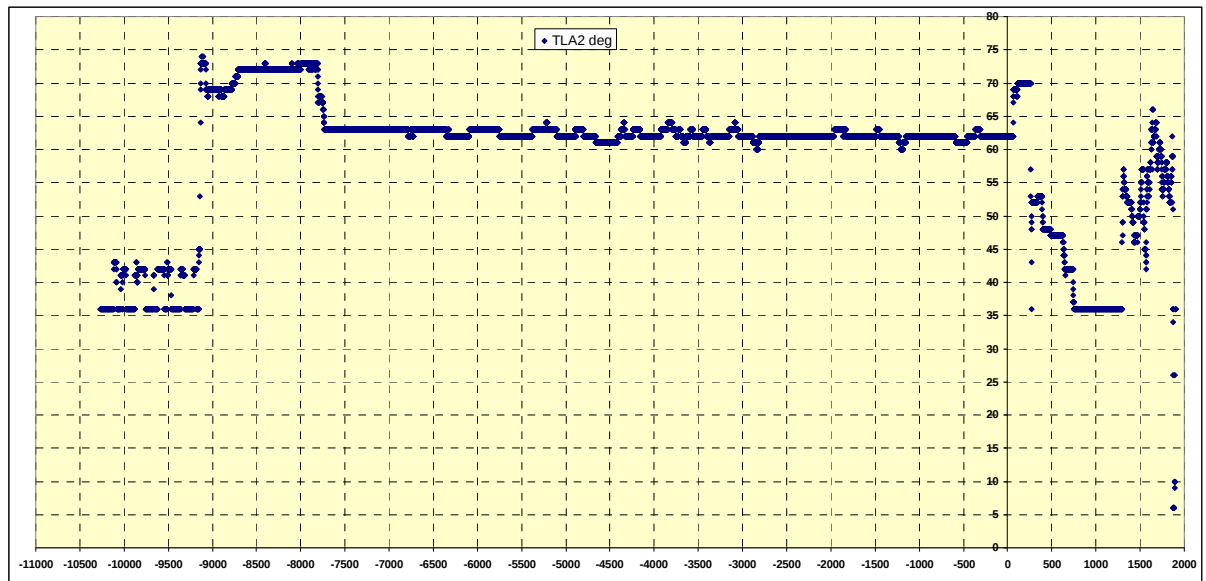
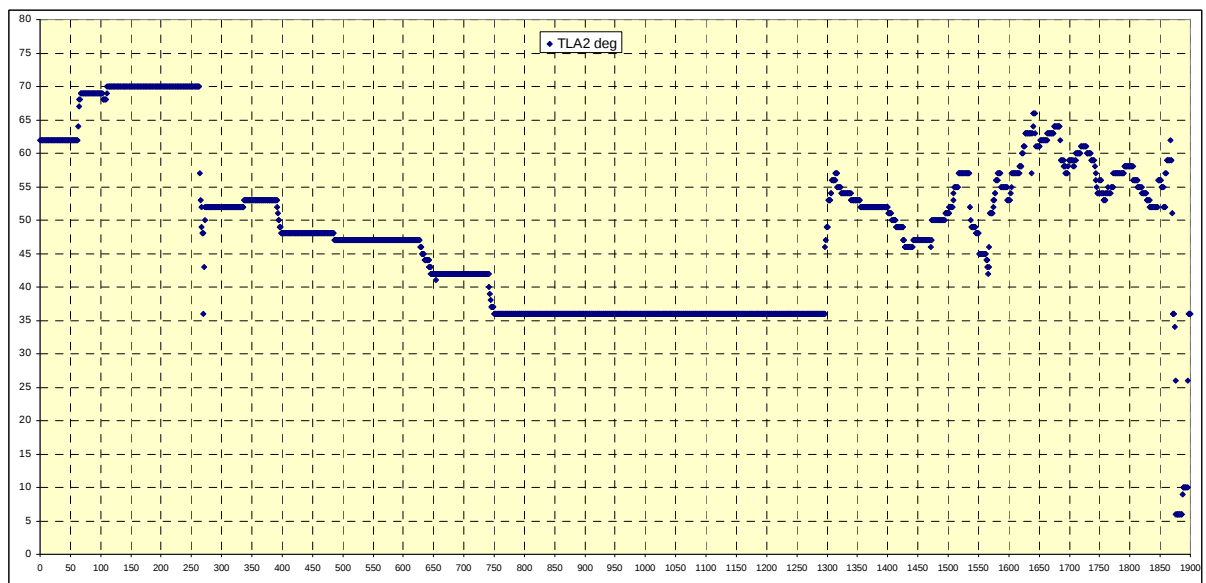
## 16. TLA Engine #2:

The TLA showed varying positions for the throttle lever up to engine shut down.

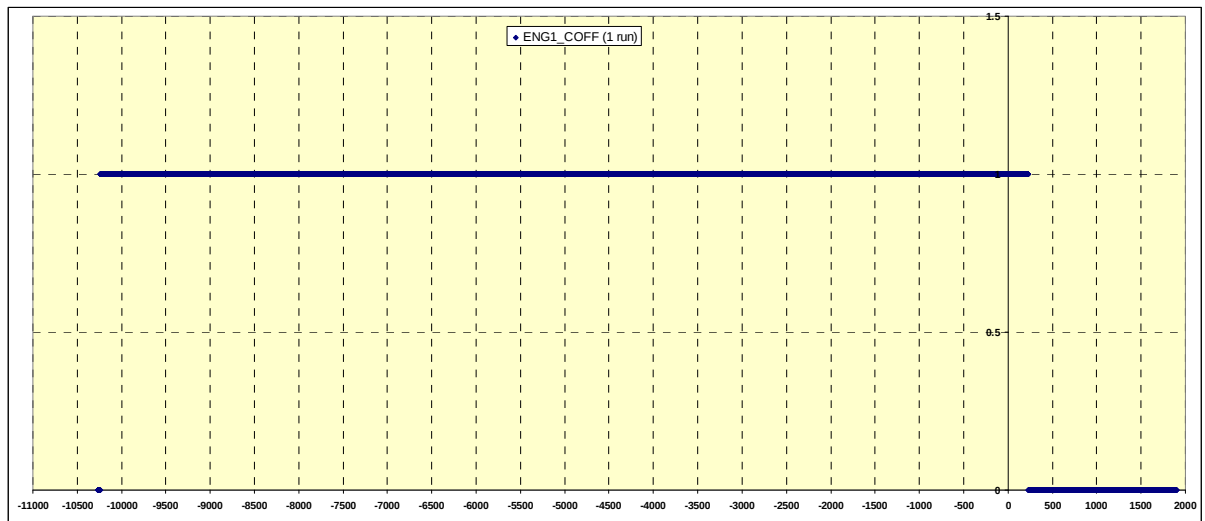
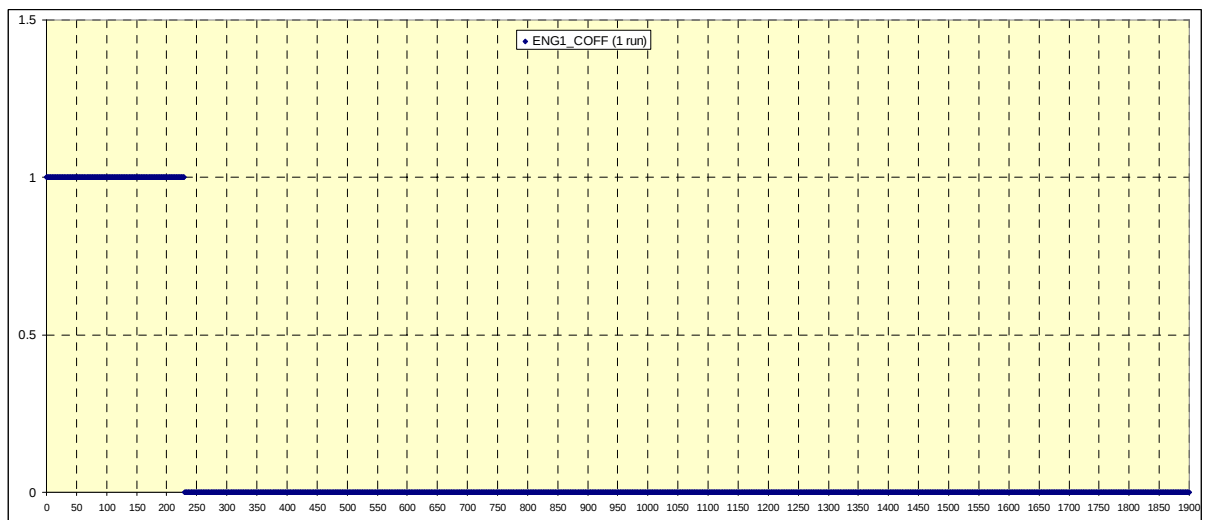
## 17. CUTOFF (discrete) Engine #1:

Start lever was moved to shut down position at about 230 seconds (204 seconds after receiving "oil press caution", 201 seconds [3 minutes, 21 seconds] after retarding the throttle lever to idle position)

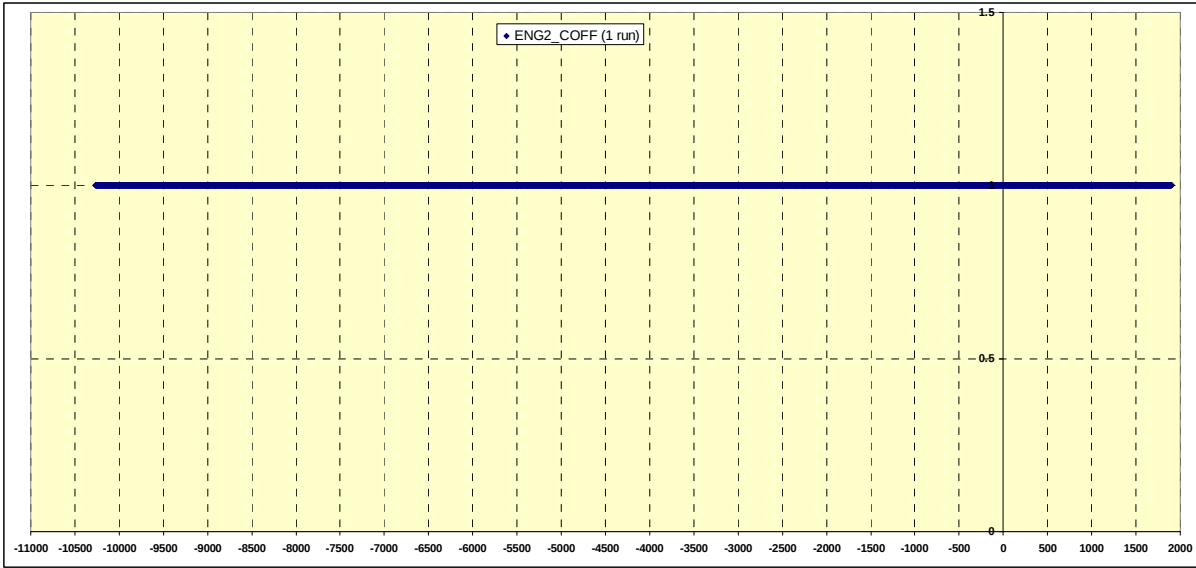
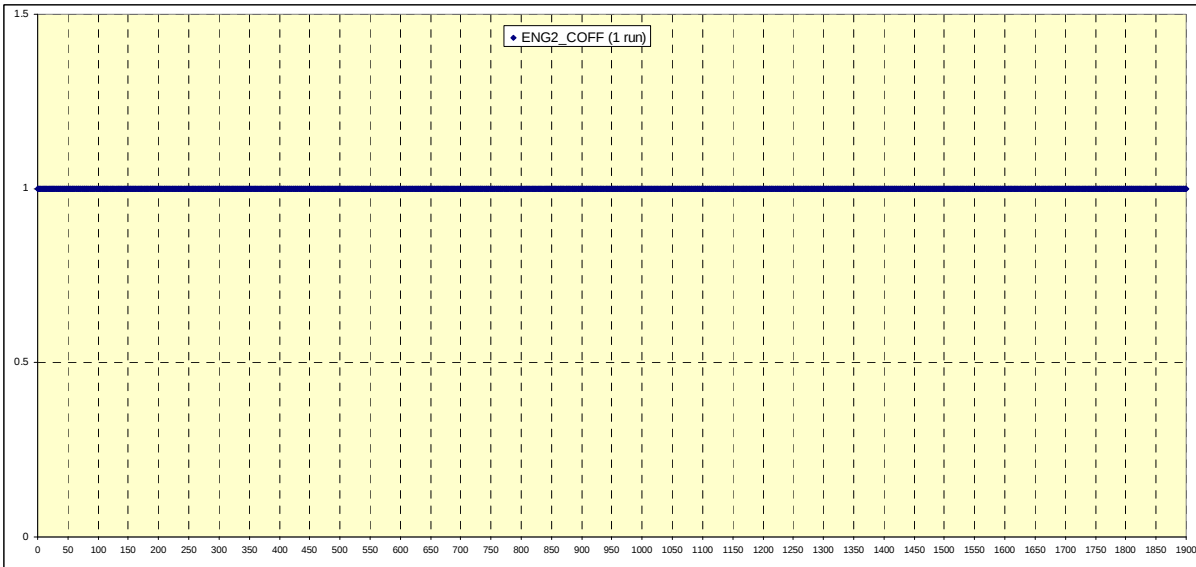
18. CUTOFF (discrete) Engine #2:

Engine number 2 continued operation up to the end of recording.

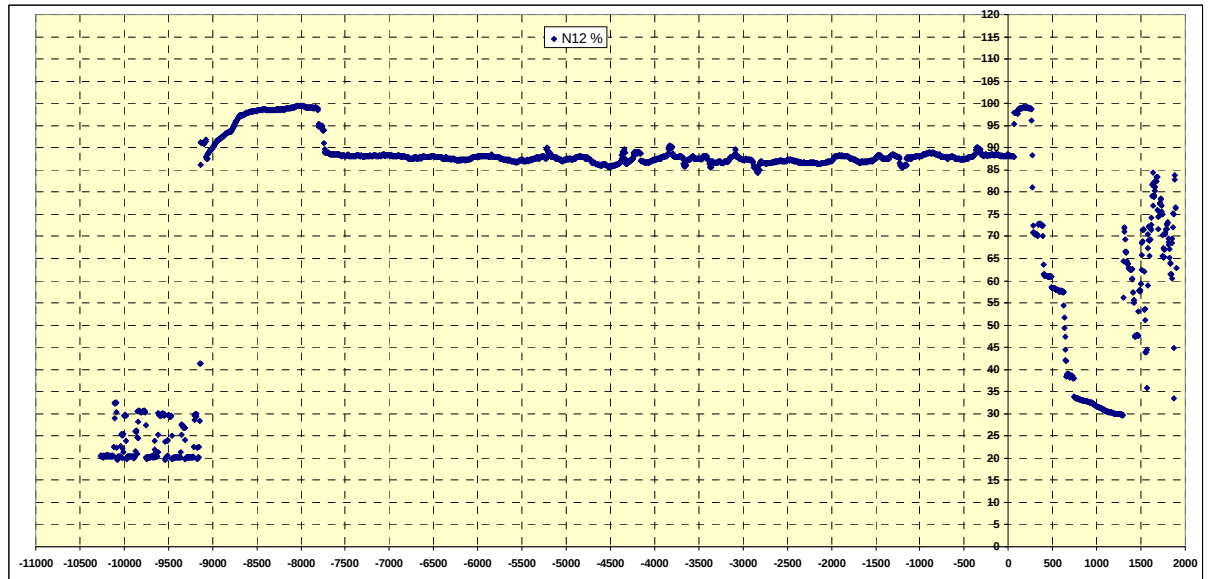
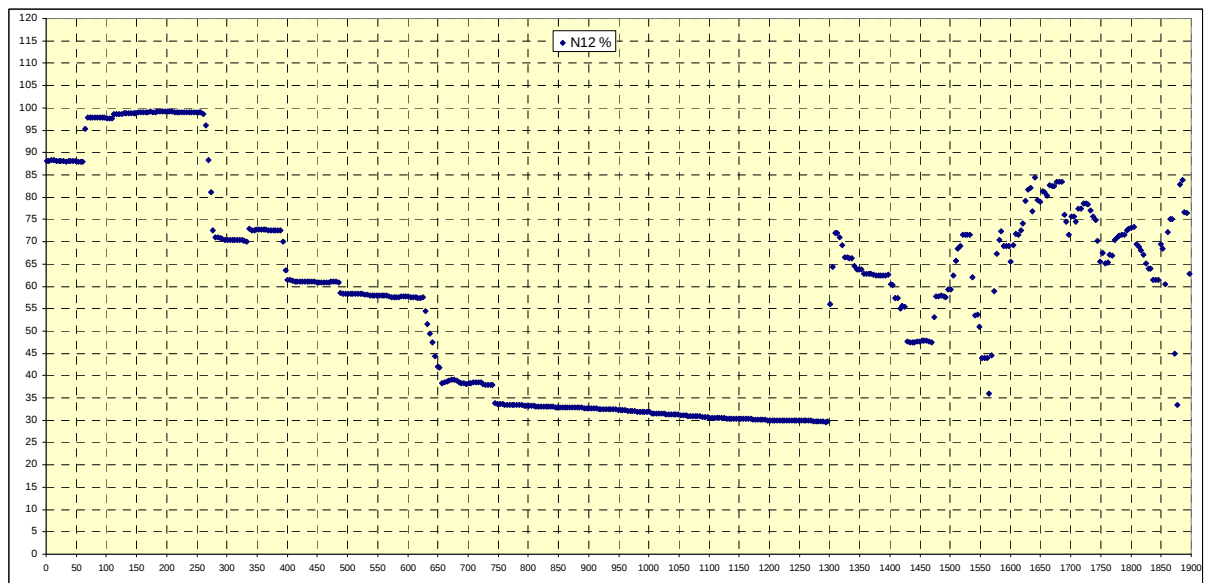
## 20. N1 Engine #2 (N12):

N12 was about 88 % up to about 61 seconds then it started increasing up reaching about 99 %

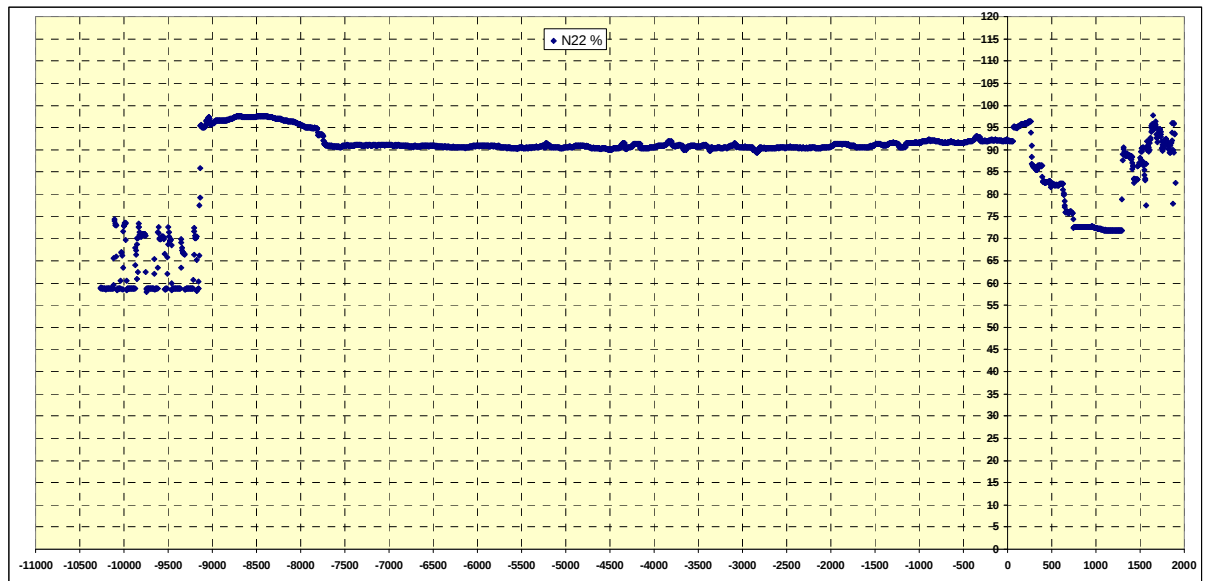
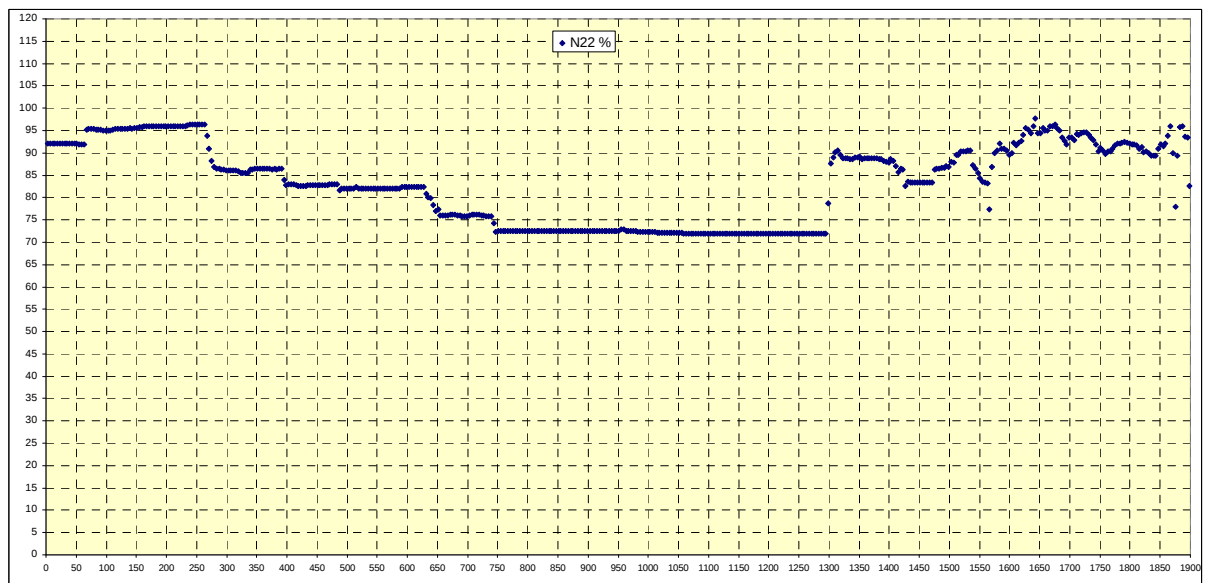
## 22. N2 Engine #2 (N22):

N22 was about 92 % up to about 63 seconds then it started varying after that (max value was almost 96 %, min value was about 72 %).

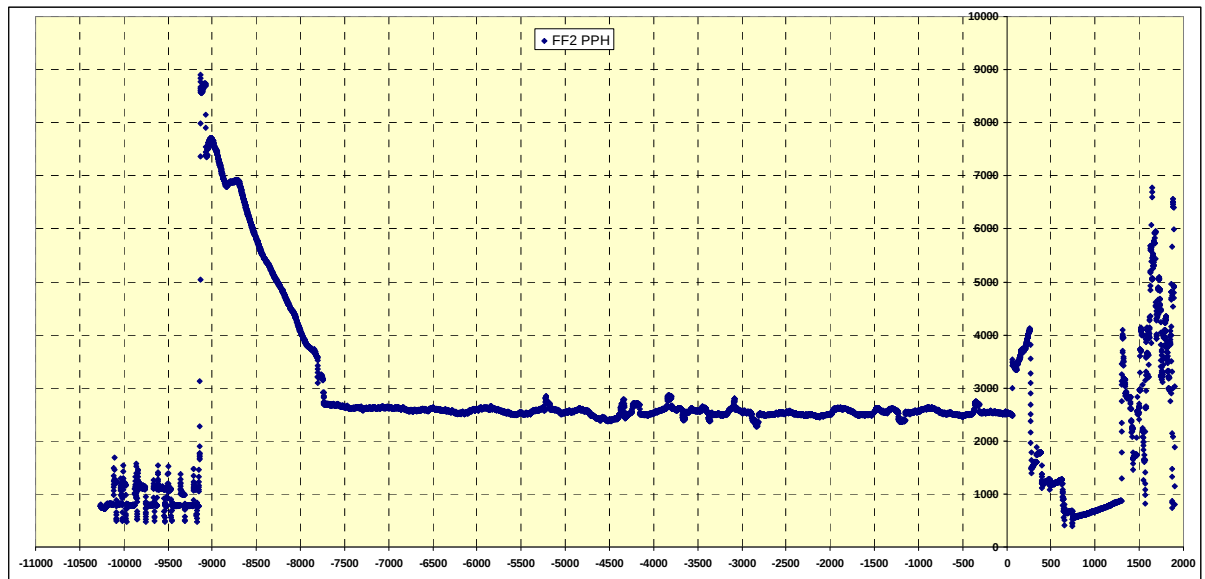
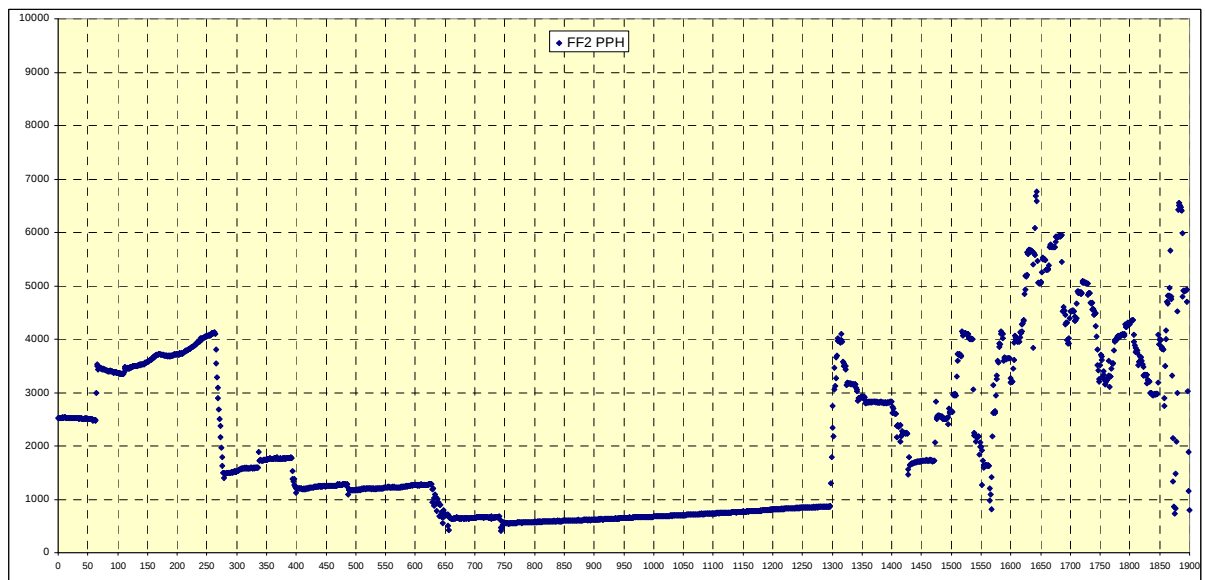
## 24. Fuel Flow Engine #2 (FF2):

FF2 was about 2528 kg/hr. Then it started varying at almost 63 seconds up to the end of recording.

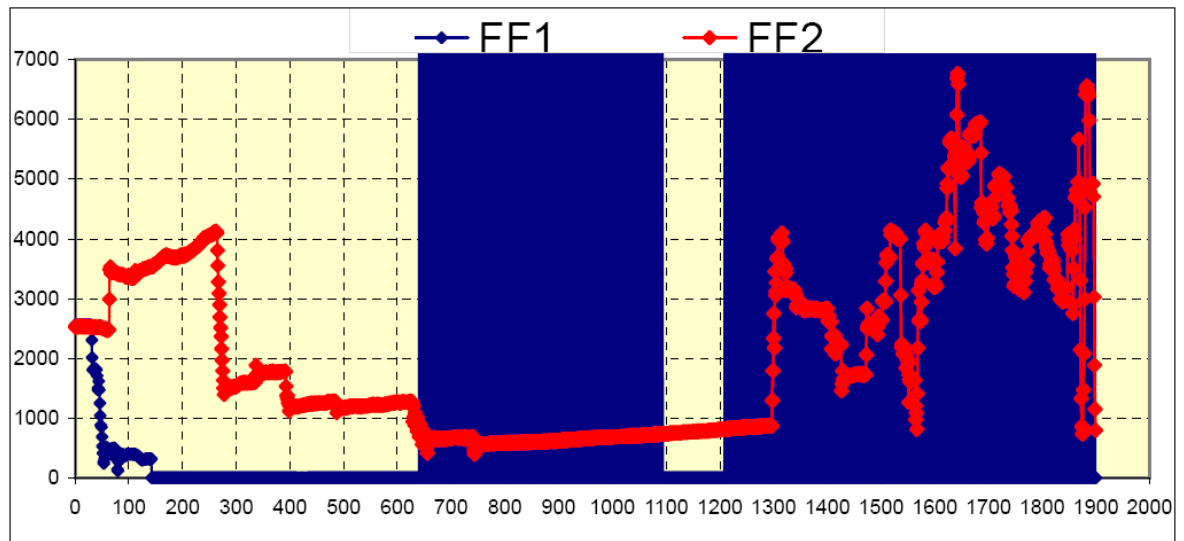
Combined Fuel Flow Engine #1, Engine #2:

FF1 was about 2560 kg/hr during cruise. At almost 30 seconds, the FF1 dropped sharply reaching zero at almost 143 second (Start lever was moved to cut off at 230 seconds)

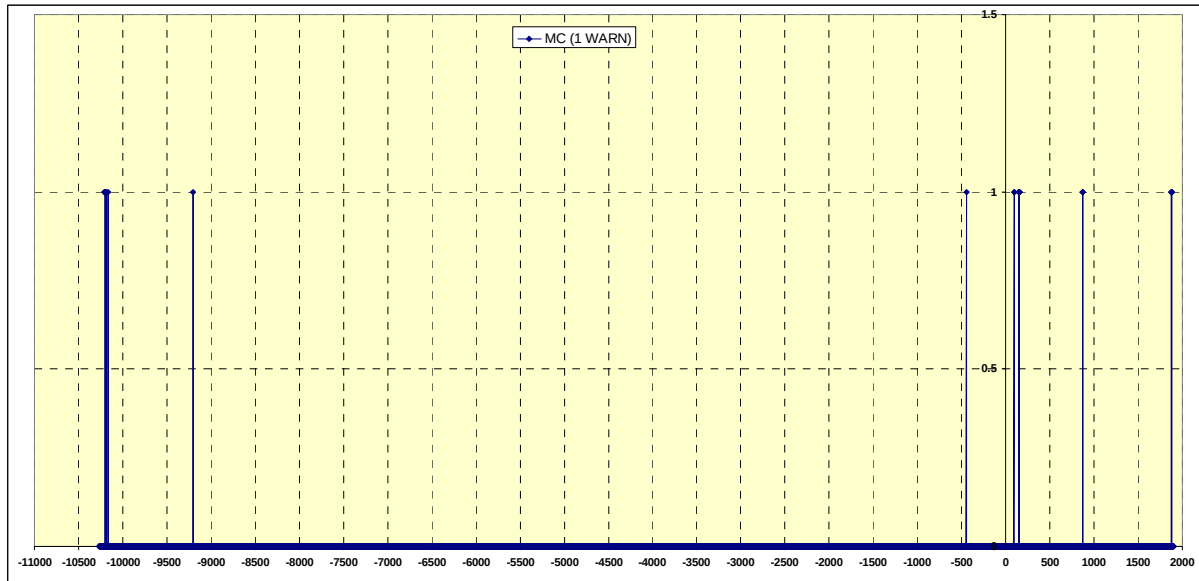
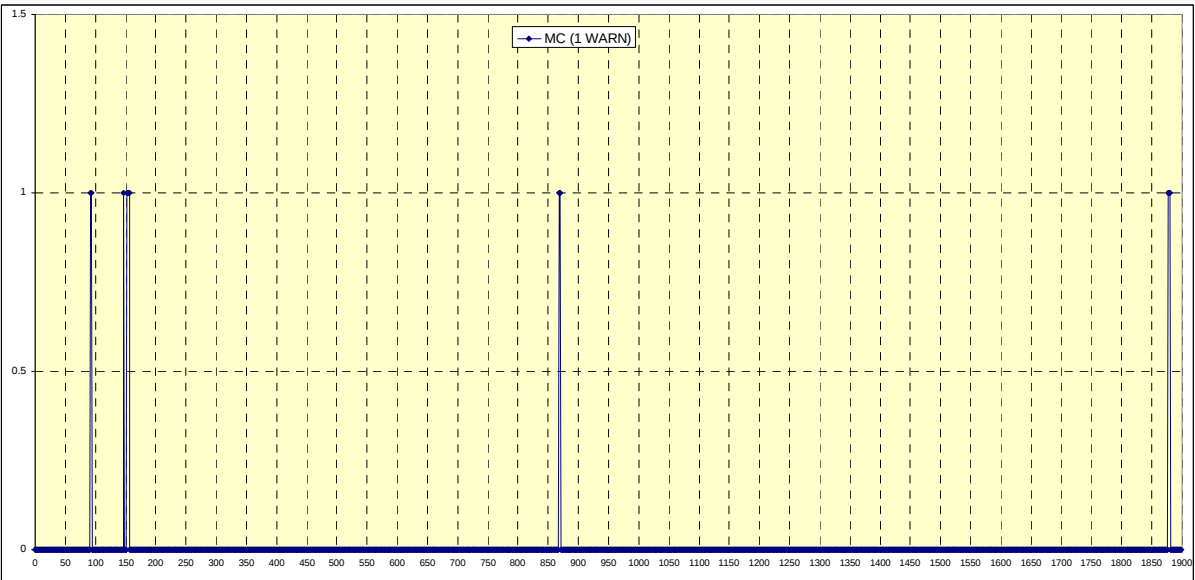
25. Master Warning:

The master warning was shown "On" at several timing as follows:

93, 147, 156, 870, 1880 seconds

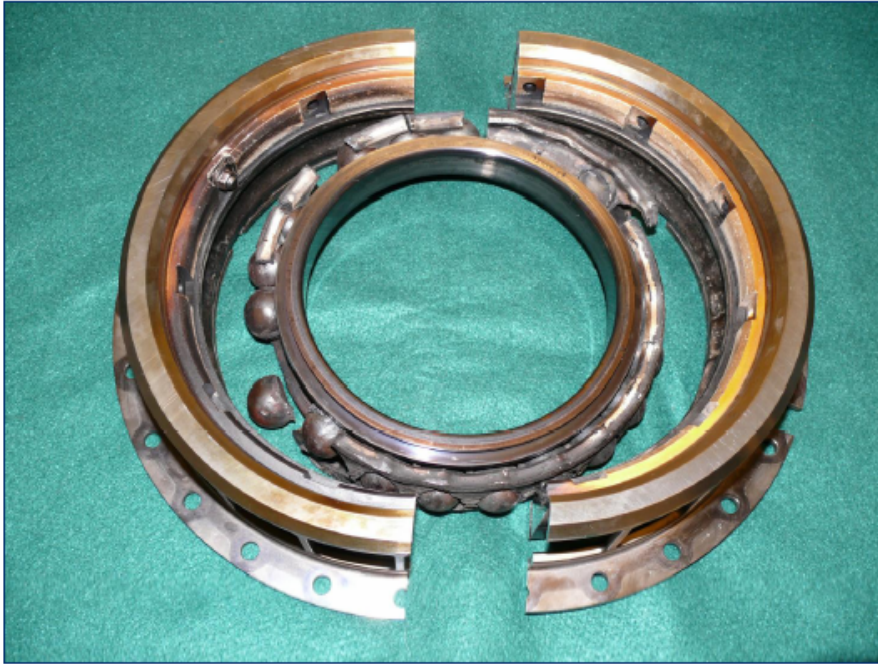
## Hardware Configuration

#3 Ball Bearing  
PN: 1665M98P02  
SN: MDALM331  
TSN: 13972  
CSN: 7127
