# Final Report

Replacing Engine #1 installed on the aircraft Boeing 737-800

Registered as UR-CLR

Aircraft Accident Investigation Central Directorate

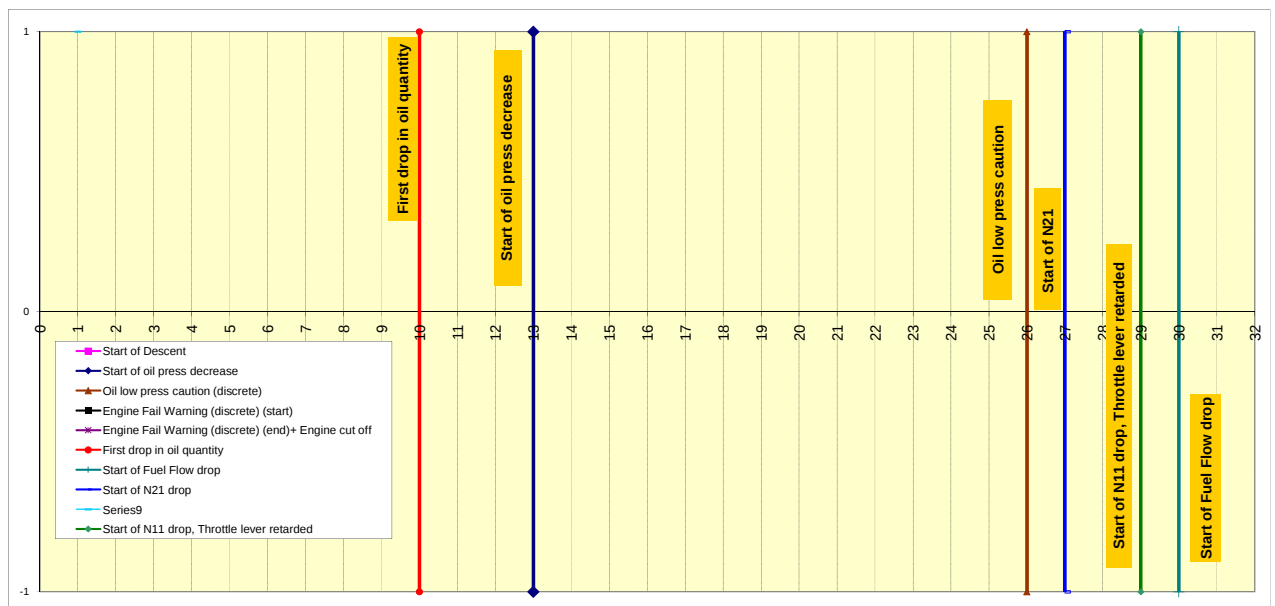
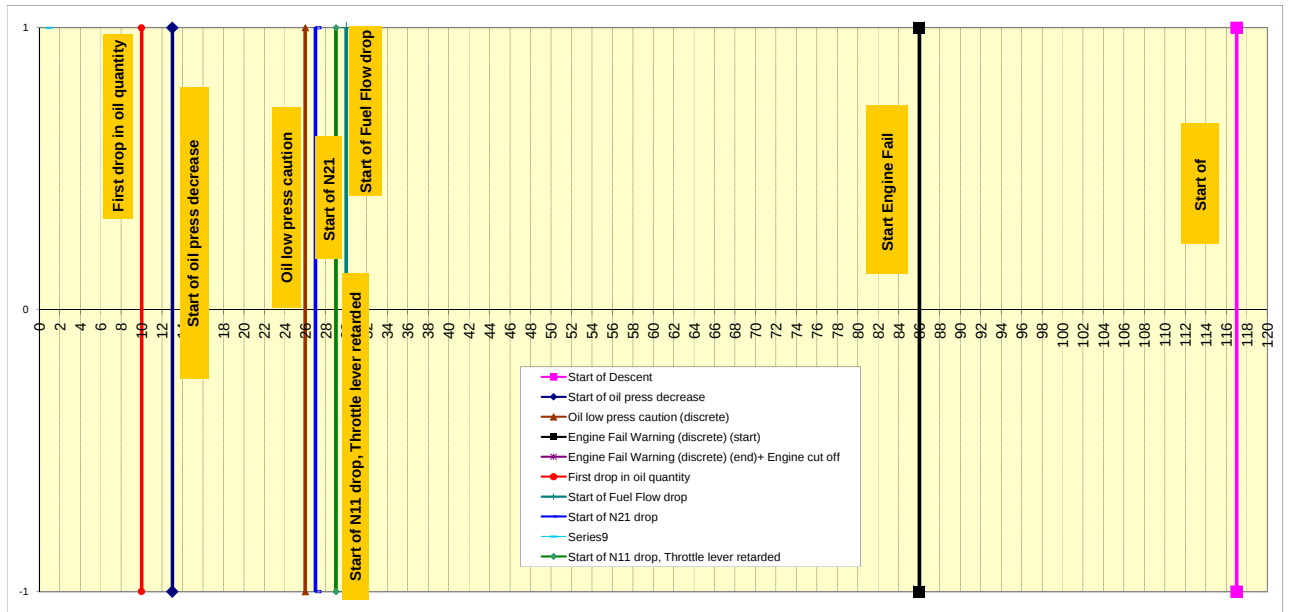
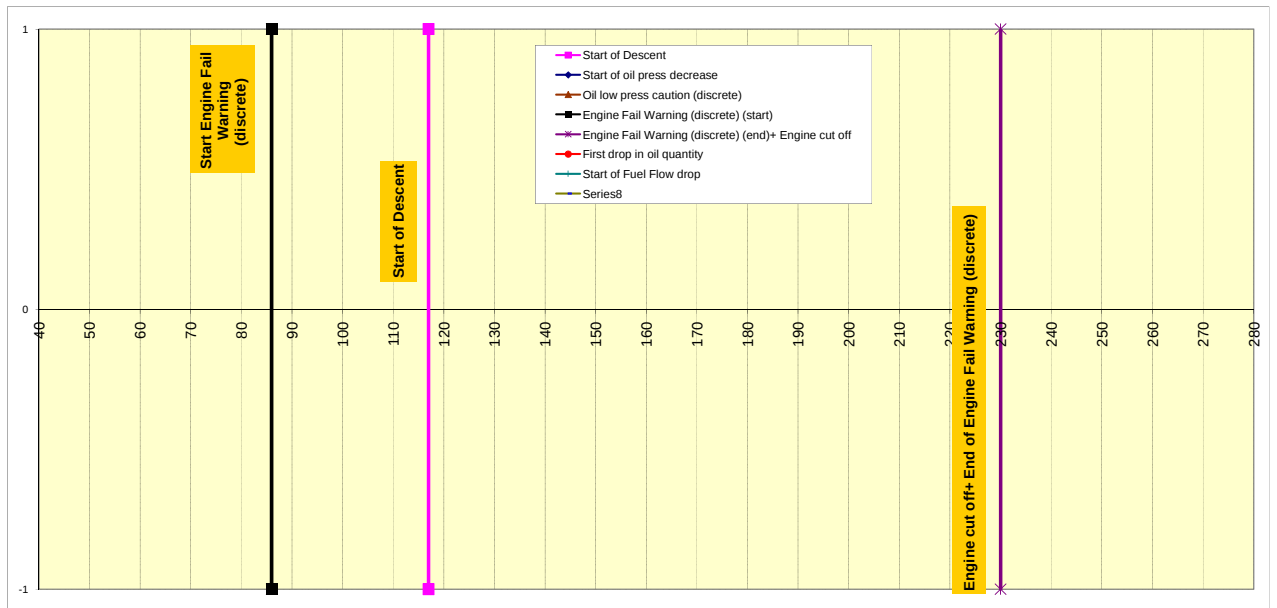
- At 10 seconds, the first drop in oil quantity occurred

- At 13 seconds, the oil started press decreasing
- At 26 seconds, the "Oil low press caution (discrete)" came on
- At 27 seconds, the N2 started dropping
- At 29 seconds the N1 started dropping, throttle lever was retarded to idle,
- At 30 seconds, the fuel flow started dropping
- At 86 seconds, the "Engine Fail Warning (discrete)" came on
- At 117 seconds, the aircraft started its descent.
- At 230 seconds, Engine start lever was moved to cut off, 'Engine Fail Warning (discrete)' was terminated.
